Program Bulletin

CUSTOMER SATISFACTION PROGRAM

SUBJECT: Convertible Top Enhancements

**MODELS: 2011-2012 Chevrolet Camaro
Equipped with Convertible Top**

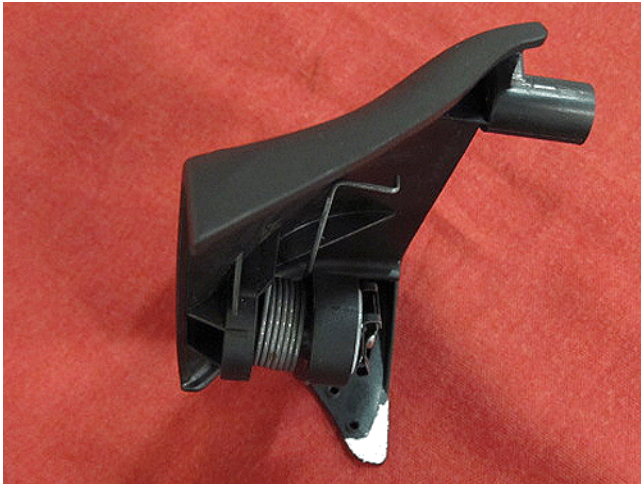
2698656

Note: In the graphic example above, the headliner corner support bracket was shown removed from the vehicle and marked for illustration purposes only. Cut off the portion of the bracket that is marked in white.

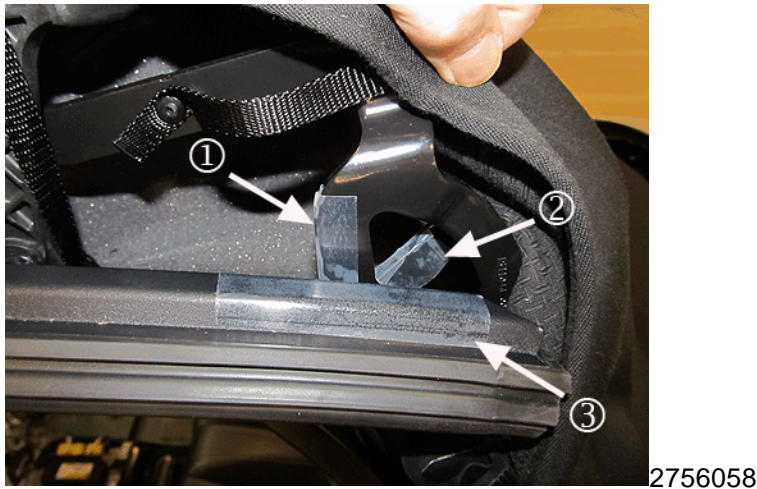
Note: It is very important to not get the different tapes mixed up. The two shorter pieces of tape that are applied to the mid-roof link will not stick to the anodized surface of the front rail.

- 11.2. Apply one of the shorter pieces of tape to the larger mid-roof link (1), on each side.
- 11.3. Apply one of the shorter pieces of tape to the smaller mid-roof link (2) that is located behind the larger link, on each side.
12. Apply the 3 inch (76 mm) length of tape (3) to the front rail section as shown in the graphic above, on each side.
13. Using a heat gun, apply heat to all six of the tape locations (three pieces of tape on each side). The application of heat aids in wetting out the tape and allows it to take shape to the links for a better overall appearance.
14. Cycle the top and verify proper operation.
