Program Bulletin

CUSTOMER SATISFACTION PROGRAM

SUBJECT: Convertible Top Enhancements

**MODELS: 2011-2012 Chevrolet Camaro
Equipped with Convertible Top**

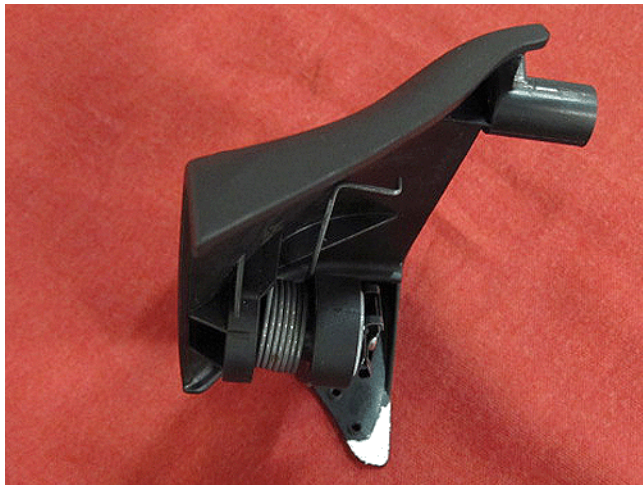
2698656

Note: In the graphic example above, the headliner corner support bracket was shown removed from the vehicle and marked for illustration purposes only.

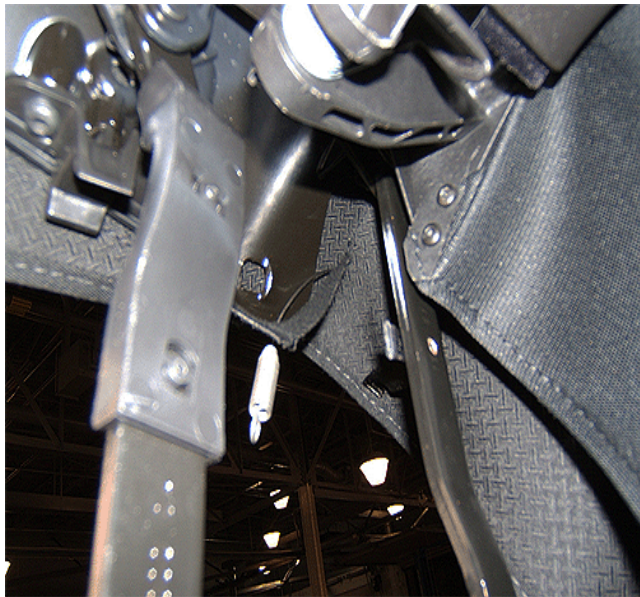
2661674

Note: The view above is how the cable will look with the cable spring routed through the top cover, rather than the #1 bow.
