AT12-003

ITB12-027

May 15, 2012

## 2010 - 2011 G37; SHIFT RESPONSIVENESS ISSUES

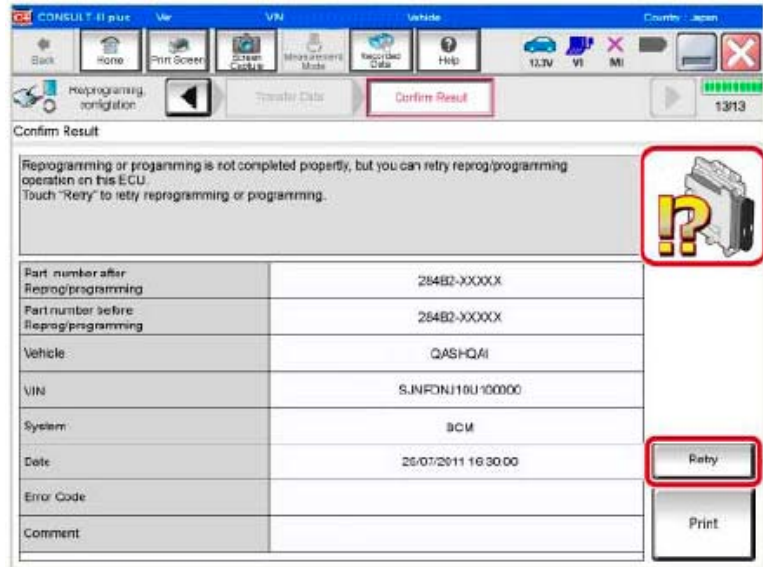
Figure 7

If reprogramming does not complete and the “!?” icon displays as shown in Figure 7:

- Check battery voltage (12.0–15.5 V).
- Ignition is ON, engine OFF.
- External Bluetooth® devices are OFF.
- All electrical loads are OFF.
- Select retry and follow the on screen instructions.
- “Retry” may not go through on first attempt and can be selected more than once.

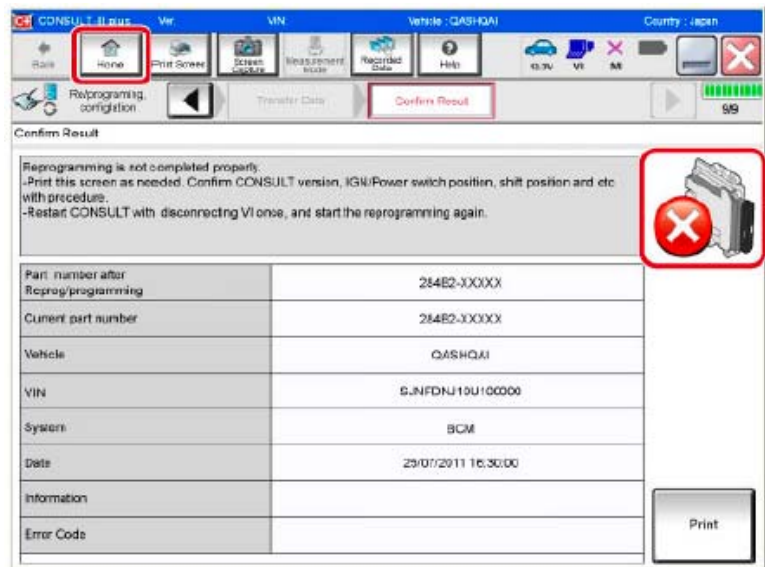
Figure 8

If reprogramming does not complete and the “X” icon displays as shown in Figure 8:

- Check battery voltage (12.0 – 15.5 V).
- CONSULT A/C adapter is plugged in.
- Ignition is ON, engine OFF.
- Transmission is in Park.
- All C-III plus / VI cables are securely connected.
- All C-III plus updates are installed.
- Select Home, and restart the reprogram procedure from the beginning.
