Service Bulletin

Bulletin No.: 11-06-04-007B

Subject: Diagnosis and Repair - Malfunction Indicator Lamp (MIL) Illuminated, Reduced Engine Power Message Displayed, DTC P2135 Set

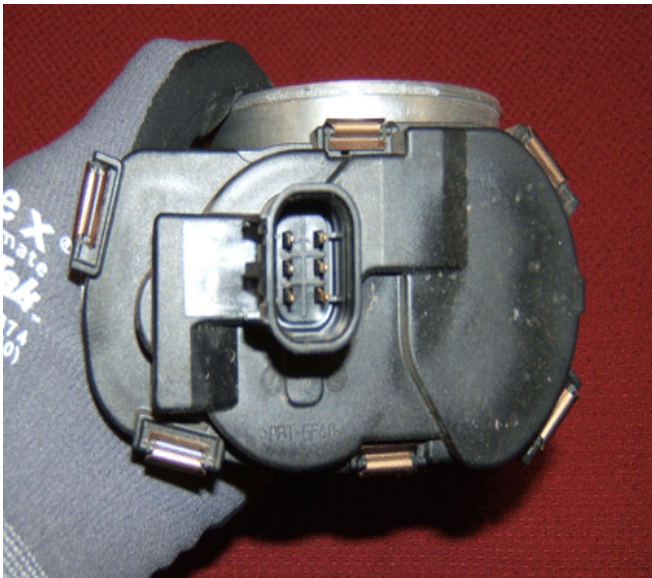
2696698

6. Clean the throttle body bore and the throttle plate using a clean shop towel with GM Top Engine Cleaner, P/N 1052626 (in Canada, P/N 993026), or AC-Delco Upper Engine and Fuel Injector Cleaner, P/N X66-P, or an equivalent product.

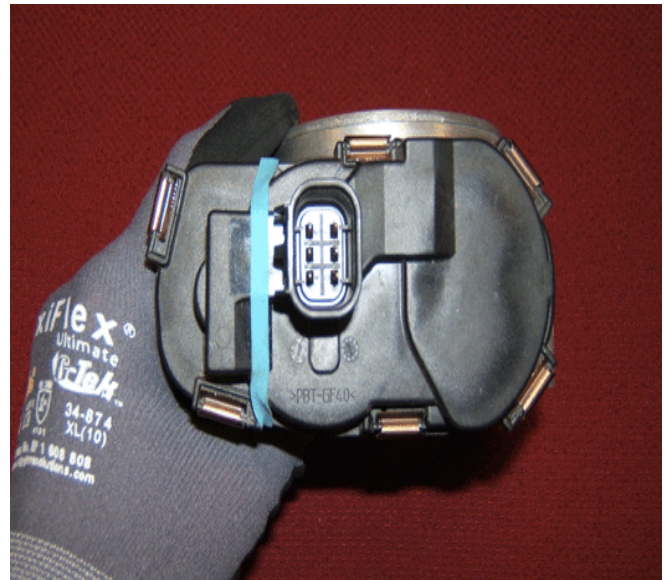
2697177

7. Hold the throttle body with your hand, so that the throttle position (TP) sensor cover is facing upward as shown.

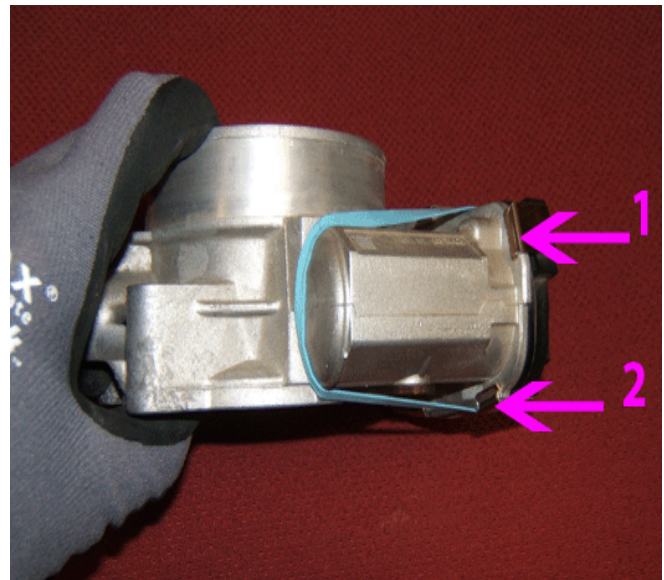
2697335

8. Secure a rubber band around the throttle body and TP sensor cover as shown.

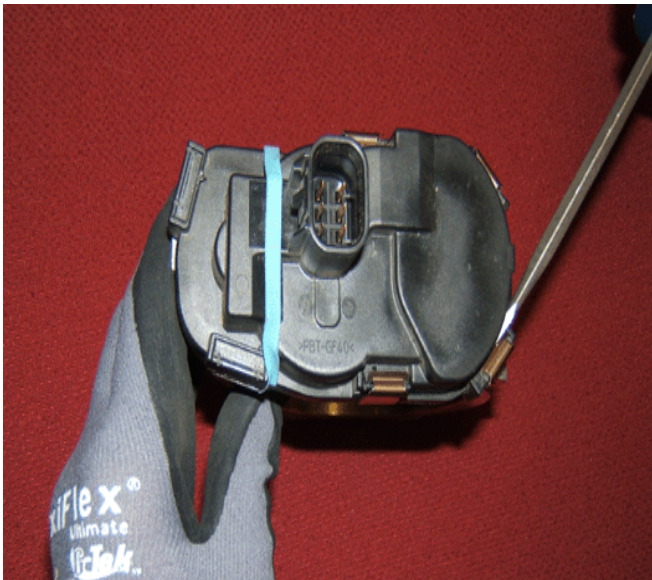
2697396

9. Turn over the throttle body and use a flathead screwdriver to remove the two clips (1, 2) as shown. Discard the clips.

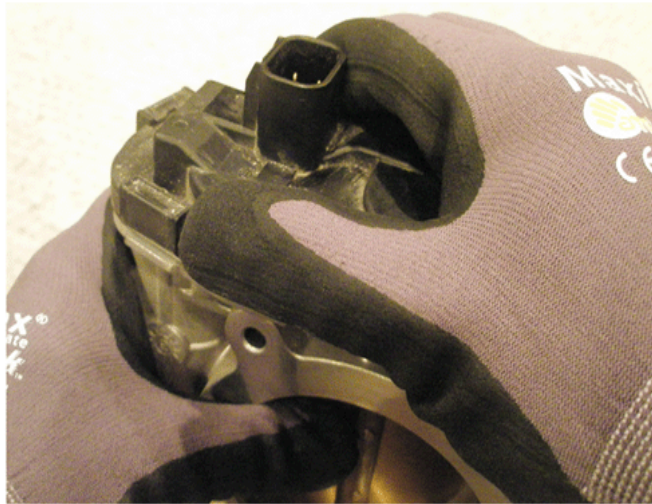
2697514

10. Turn over the throttle body and use a flathead screwdriver to remove the four remaining clips from the TP sensor cover. Discard the clips.

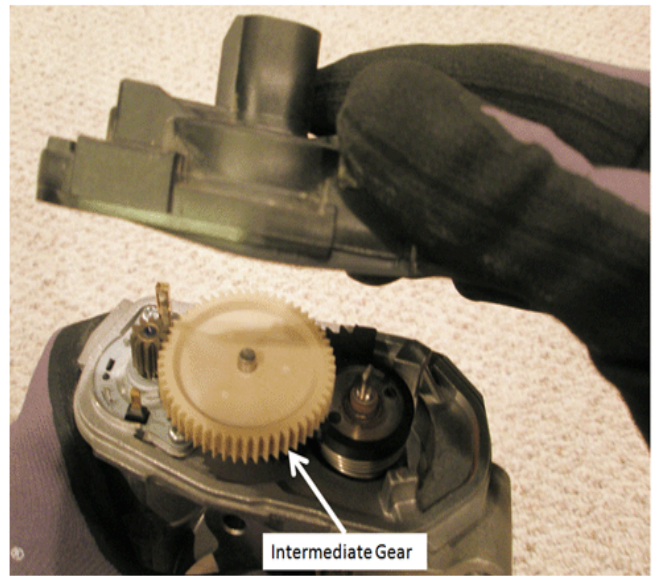
2697650

11. Hold the throttle body with your hand, so that the TP sensor cover is facing upward. Grasp the TP sensor cover and carefully lift it up and separate it from the throttle body.

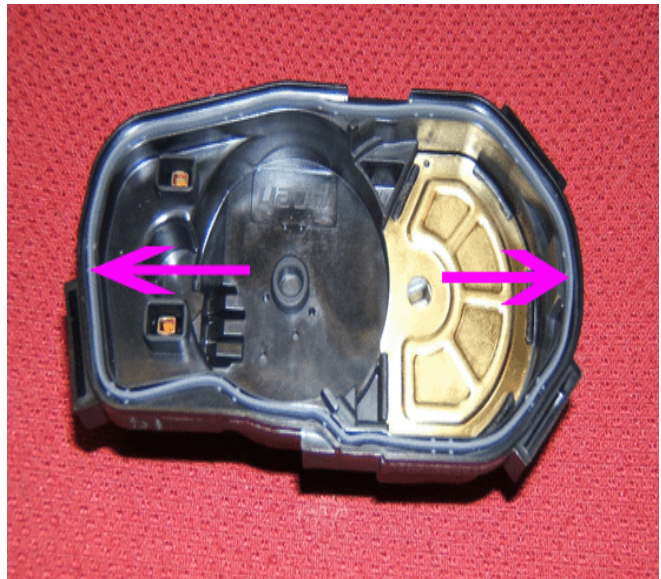
2697675

12. Maintain the throttle body in an upward position. Use your thumb to maintain contact with the intermediate gear.
- ⇒ If the intermediate gear falls out and impacts a hard workbench surface or the floor, abort this procedure and REPLACE with a new throttle body assembly.

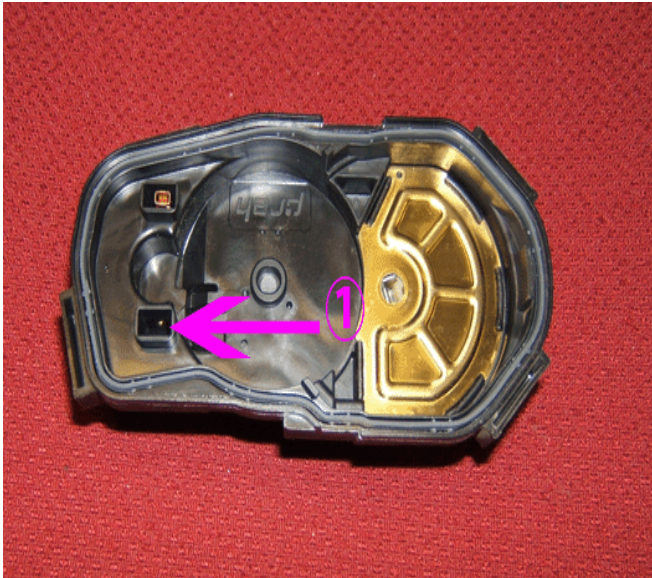
2697721

13. Verify that the TP sensor cover gasket HAS REMAINED in the TP sensor cover as shown. Ensure that the gasket is accounted for and remains with the old TP sensor cover.

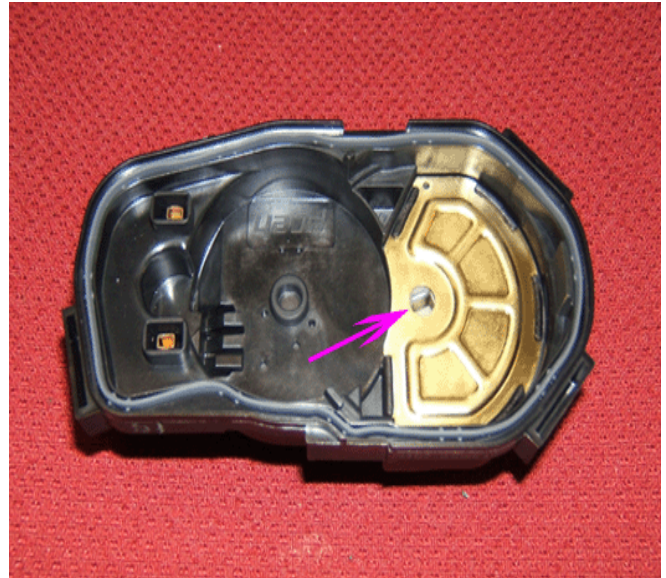
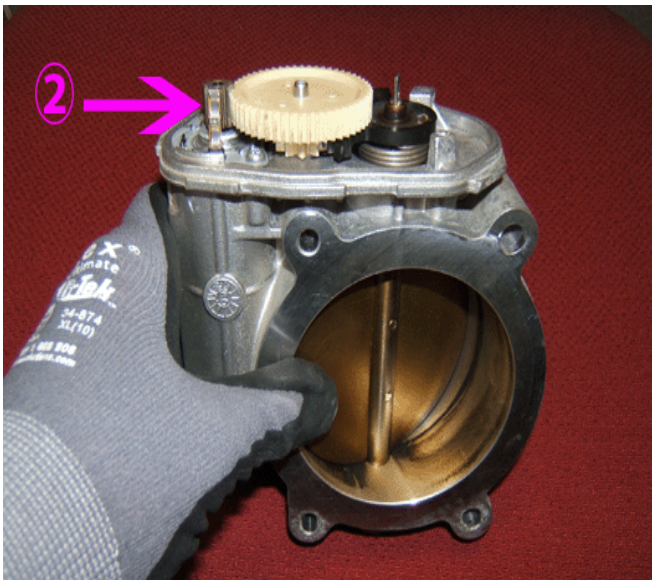
14. Observe the TP sensor cover for missing female throttle actuator motor terminals (1). Verify that the female throttle actuator motor terminals HAVE REMAINED in the TP sensor cover and HAVE NOT been retained on the throttle actuator motor male terminals (2). Discard the old TP sensor cover, gasket and terminals.

⇒ If one or both of the TP sensor cover female throttle actuator motor terminals HAVE BEEN retained on the throttle actuator motor male terminals (2), remove and discard those female terminals.

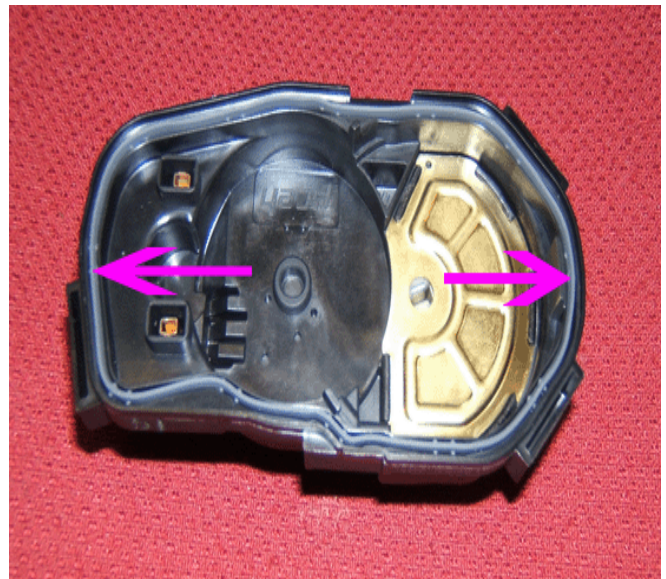
2697675

16. Place the TP sensor cover in the position as shown. Confirm the TP sensor drive slot orientation is aligned in the TP sensor cover as shown.

⇒ If the TP sensor drive slot orientation is not aligned as shown, use a small flathead screwdriver to gently rotate the TP sensor drive slot **clockwise** to the wide open throttle (WOT) position as shown.

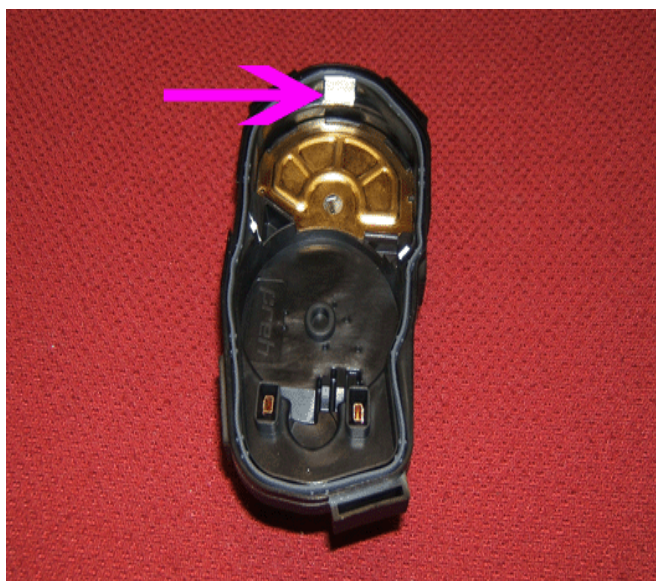
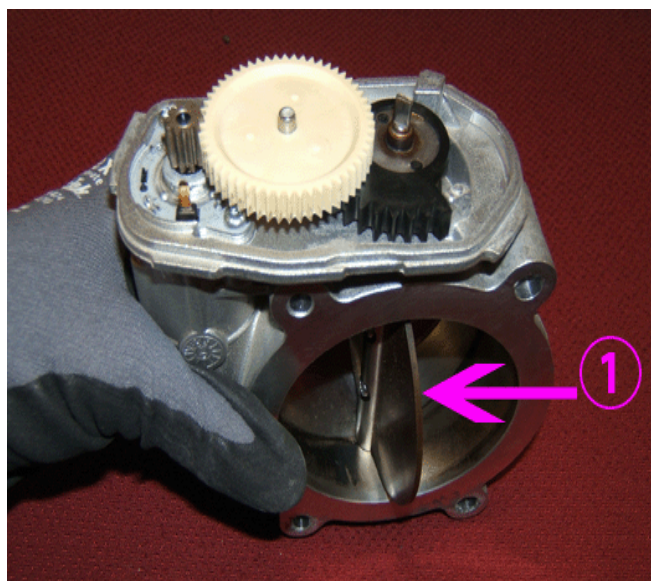
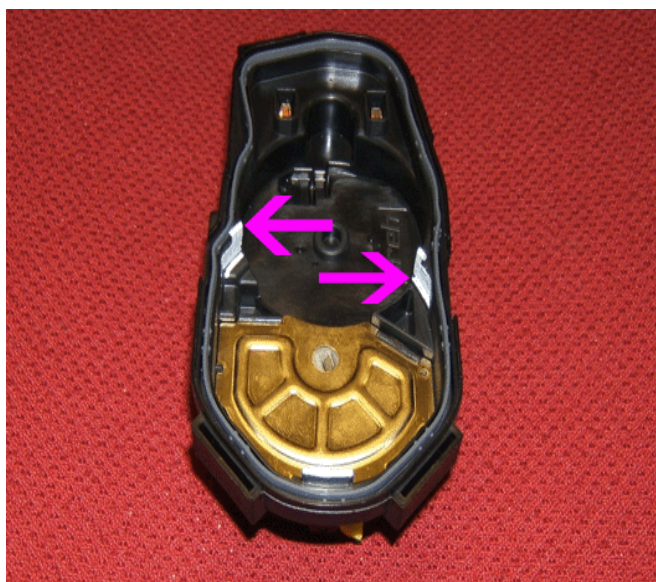
17. Verify that the TP sensor cover gasket is secure and properly positioned.

Notice: The three TP sensor cover alignment tabs are highlighted in white for identification purposes only.

18. Verify that all three of the TP sensor cover alignment tabs are present and are not damaged.
19. Grasp and hold the throttle body in the previously hand held upward position. Lightly depress the intermediate gear to verify that it is fully seated and the gears are engaged.

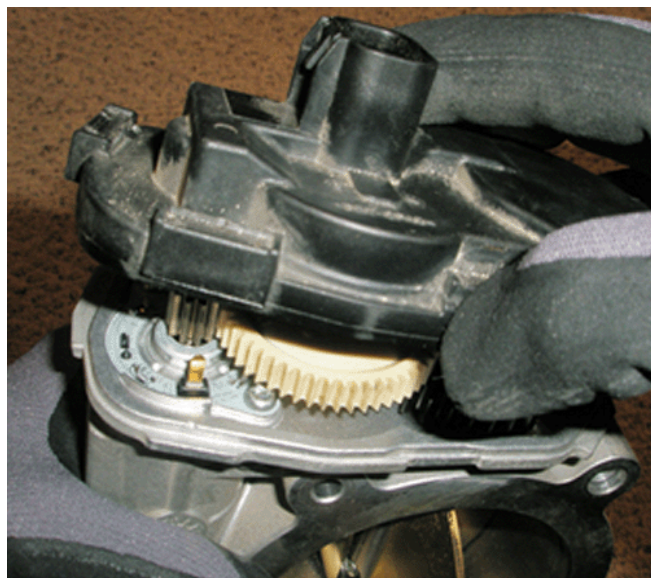
2699101

20. Rotate the throttle body plate to the WOT position (1).

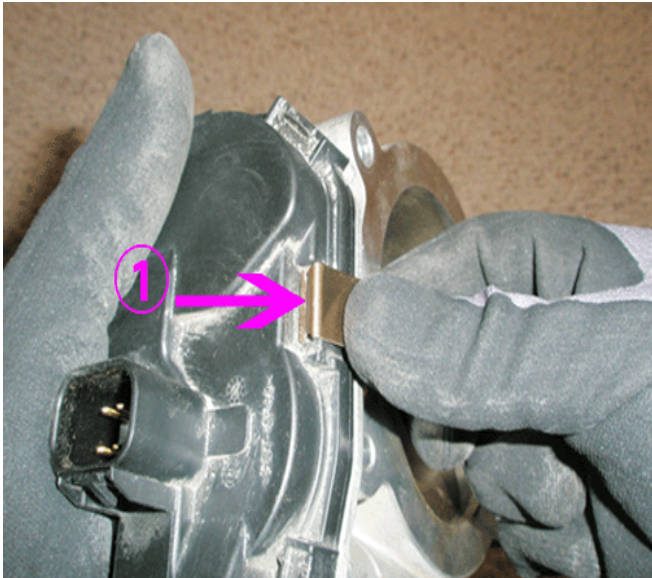
2700151

21. Position and install the TP sensor cover to the throttle body. Hold the TP sensor cover in position. If necessary for ease of the clip installation, secure a rubber band around the throttle body and TP sensor cover.

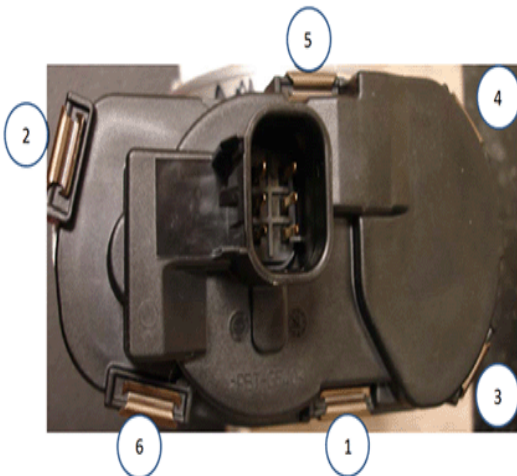
2699881

22. Install the first TP sensor cover clip (1) in the position shown.
