Service Bulletin

Bulletin No.: PIC5667A

Subject: Service Power Steering Message DTC C0800

Models: 2011-2013 Chevrolet Volt

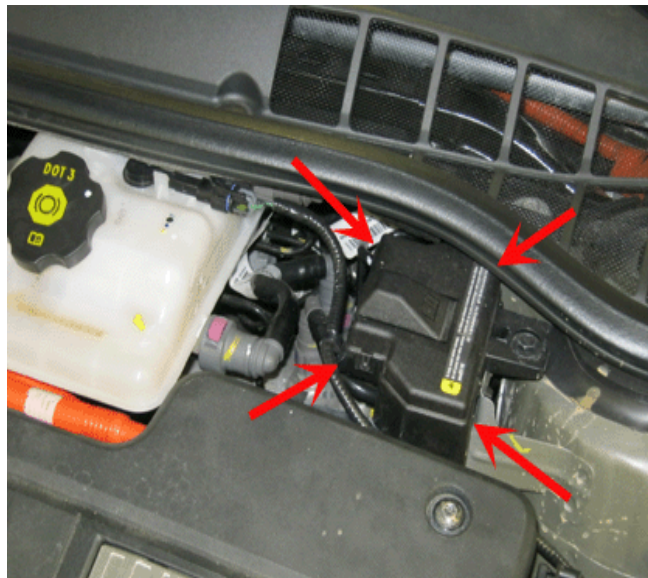
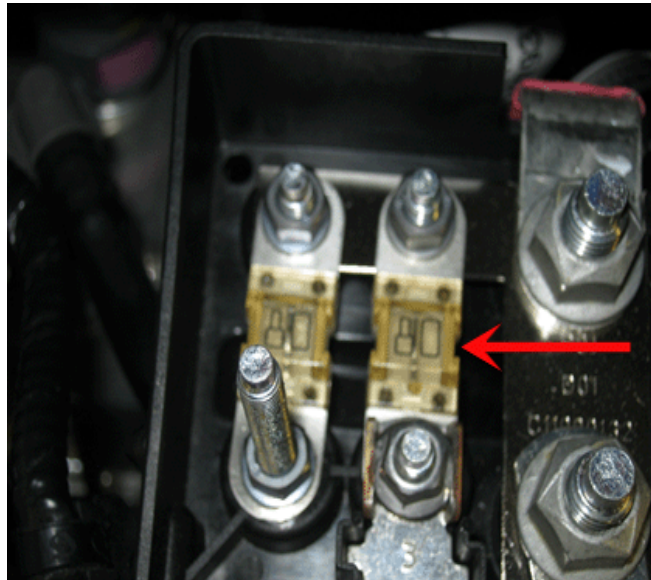
2814516

Some customers may experience a "Service Power Steering" message at times. The concern may also be followed by a current or history code C0800 set in the power steering control module.

1. Check the F2UB (80 amp) fuse connection in the X50 auxiliary under hood fuse box. Check for a loose connection by checking the torque on the nut. Also check for any signs of arcing. If there is signs of arcing, replace the fuse and torque to the proper spec's.
