Service Bulletin

Bulletin No.: PIC5667

Subject: Service Power Steering Message DTC C0800

Models: 2011 - 2012 Chevrolet Volt

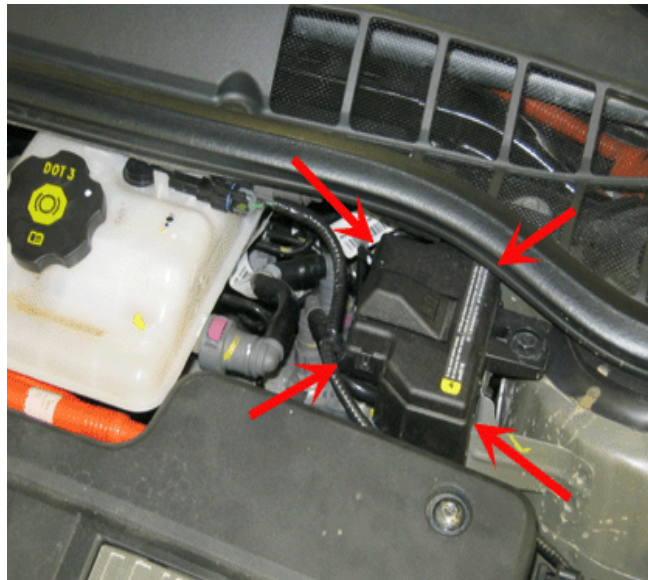
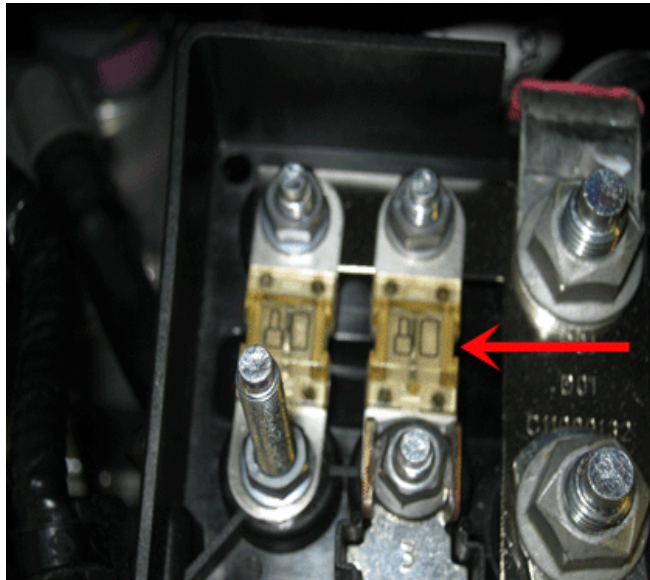
2814516

1. Check the F2UB (80 amp) fuse connection in the X50 auxiliary underhood fusebox. Check for a loose connection by checking the torque on the nut. Also check for any signs of arcing. If there is signs of arcing, replace the fuse and torque to the proper spec's.

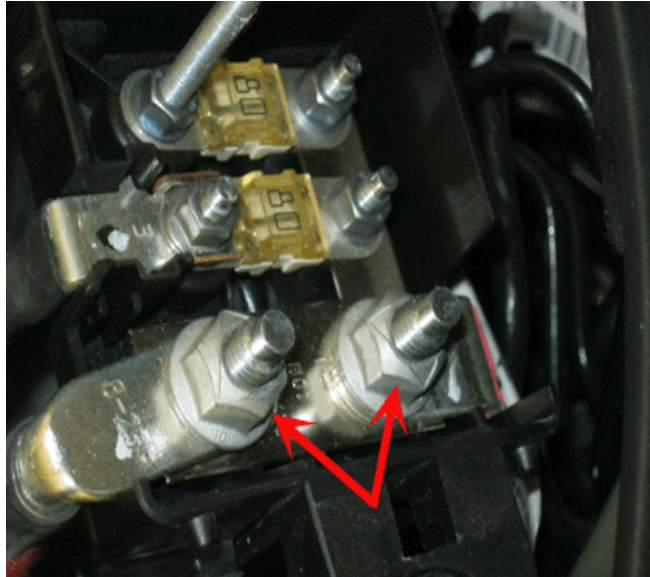
2814517

2. Check the torque on the main power feeds cable at the X50 auxiliary underhood fusebox. If loose, torque to factory spec's and retest system.
