### Connector Pin, Replacement

VN, VHD, VT, VAH  
D11, D13, D16

## FSB 255-023, Connector Pin, Replacement

(April 2012)

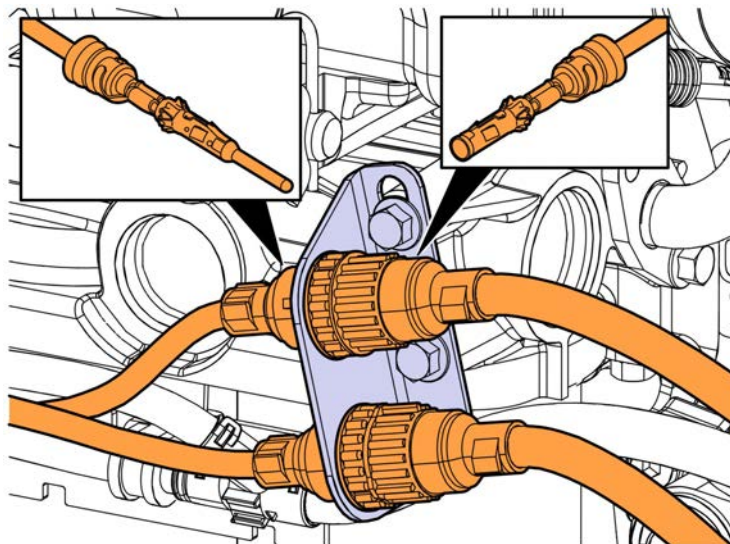
W2072541

Severe fretting damage of the Engine Variable Geometry Turbocharger Actuator (Engine VGT Actuator) harness and Turbine Shaft Speed Sensor (TSS) connectors may cause an unreliable signal to the engine VGT Actuator on certain VOLVO VN, VHD, VT, and VAH trucks. An unreliable signal to the engine VGT Actuator will generate Diagnostic Trouble Codes (DTCs). If DTCs are logged and pin fretting is identified as the cause, the engine VGT Actuator and TSS connector pin and socket contacts should be replaced. Replacement of the pin and socket contacts will eliminate pin fretting and increase the reliability of the signal to the engine VGT Actuator.
