Connector Pin, Replacement

CHU, CXU, GU, LEU, MRU, TD, CMM, CMH
MP7, MP8, MP10

FSB 255-023, Connector Pin, Replacement

(April 2012)

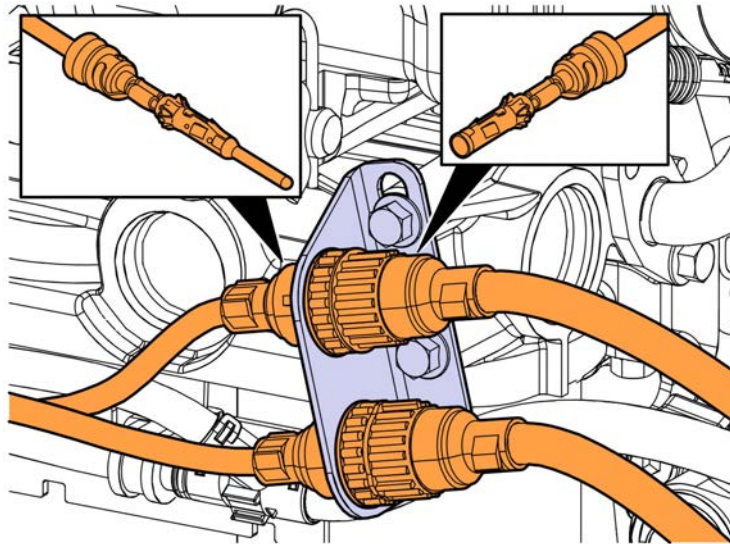
W2072541

Severe fretting damage of the Engine Variable Geometry Turbocharger Actuator (Engine VGT Actuator) harness and Turbine Shaft Speed Sensor (TSS) connectors may cause an unreliable signal to the engine VGT Actuator on certain MACK CHU, CXU, GU, LEU, MRU, TD, CMM, and CMH trucks. An unreliable signal to the engine VGT Actuator will generate Diagnostic Trouble Codes (DTCs). If DTCs are logged and pin fretting is identified as the cause, the engine VGT Actuator and TSS connector pin and socket contacts should be replaced. Replacement of the pin and socket contacts will eliminate pin fretting and increase the reliability of the signal to the engine VGT Actuator.
