SB-10044280-7019

Title Repair instruction water in bulkhead.
Ref No US20698.4.0 en-GB
Issuer -
Partner 3 US 7510 Volvo Cars North America
Func Group 8114
Func Desc firewall

Volvo Car Customer Service		
	TJ Instruction	
	No. 20698	
		Date May 2012 Issue 02
Title	Repair instruction water in bulkhead.

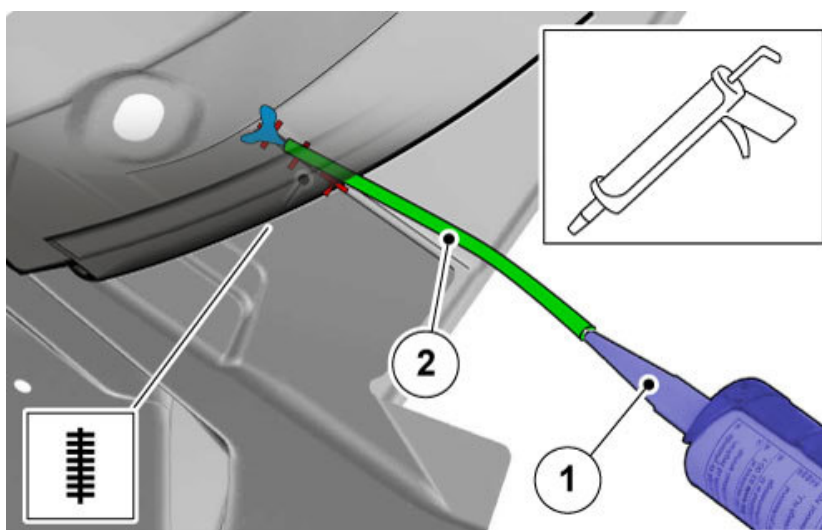
IMG-328715

When driving around a corner/round about, a water flush noise may become audible. Because of an inaccurate arc welding (a small hole in an overlap area), water that run down from the windscreen, may enter the bulkhead area.

Install the hose (2) on the nozzle (1).

Push the hose up between the window and the body frame at the welded joint up towards the adhesive bead.

Apply adhesive.
