Applies To: **2008 RL** – From VIN JH4KB166.8C000001 thru JH4KB166.8C005111

May 3, 2012

Product Update: AcuraLink Does Not Receive Messages From Acura
 (Supersedes 08-003, dated February 11, 2011, to revise the information marked by the black bars)

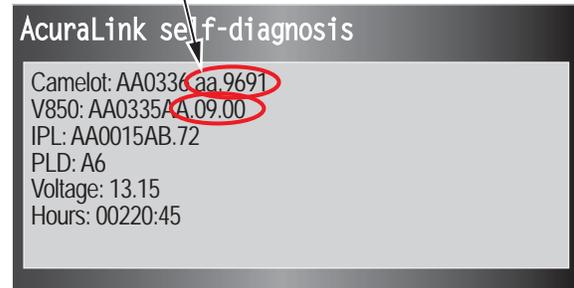
5. Check the last digits of the Camelot and the V850 versions on the screen.
 - If the digits are the same as those circled below, the update is complete.
 - If the digits are different than those circled below, load the correct software into the GNA600, then repeat the AcuraLink control unit update.

Check these two numbers.
