SB-10044299-8140

SI M31 01 12
Front Axle

Service Action: Inspect Front Axle Ball Joints

R60 (Cooper Countryman and Cooper S Countryman)

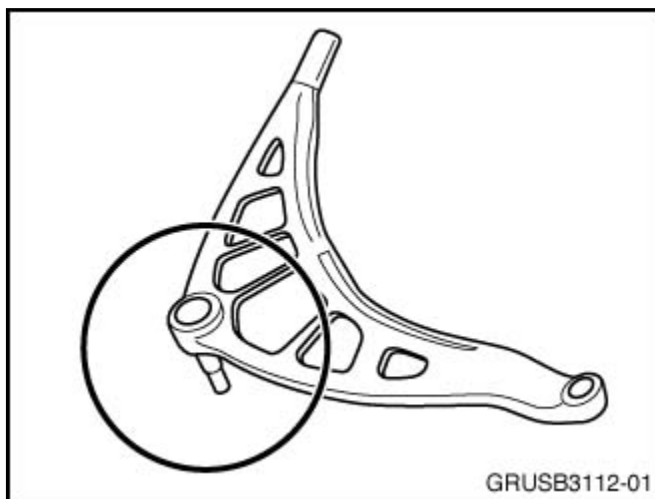
With the vehicle properly supported on a lift, inspect the front axle control arms.

The inner ball joint rubber boots must be inspected.

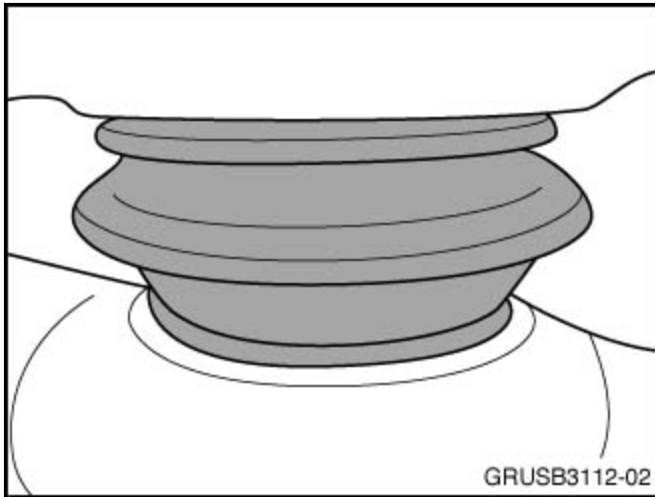
The inner ball joint rubber boot must be positioned as shown.

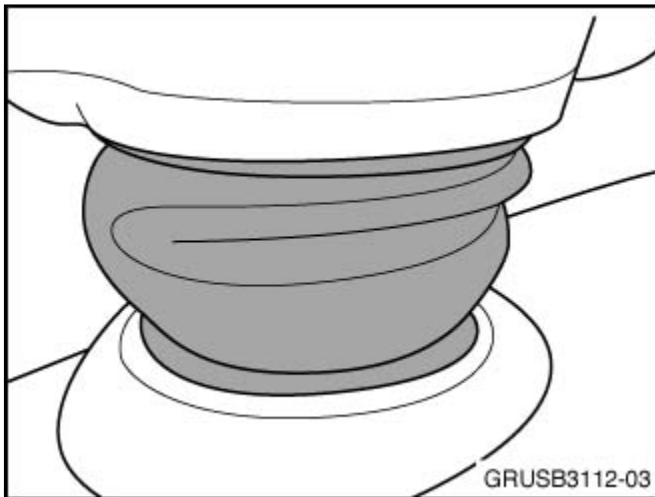
If the rubber boot for the ball joint is distorted:

- Remove the securing nut.
- Reposition the rubber boot.
- Replace the securing nut.
- Tighten the nut to specifications (refer to Tightening Torque AZD 31 12).
