Service Bulletin

NUMBER : SC-60R1

SUBJECT: SPECIAL COVERAGE EXTENSION No. ZA
"AIR BAG" Warning Light Passenger Side Seat Cushion

MODEL: Certain 2006~2011 Suzuki Grand Vitara (JB627) (JB424) (JB632)
Certain 2007~2011 SX4 (RW420)

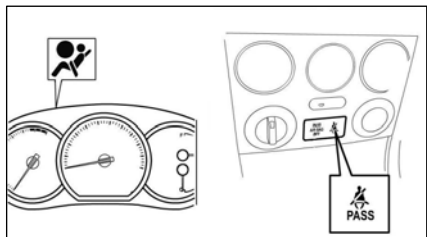
Grand Vitara

If this condition occurs, the "AIR BAG" light in the instrument cluster and front passenger's seat belt reminder light will come on. Also, the "PASS AIR BAG OFF" indicator light will remain off because the front passenger airbag will remain active during this malfunction even when a child or infant is sitting in the front seat. Other than the Front Passenger Sensing System, the air bag system will continue to operate as designed. The Diagnostic Trouble Code (DTC) B1312 identifying this condition will be stored in the vehicle on board system.

Suzuki will provide special extended coverage for passenger seat sensor mat failures for the B1312 DTC condition for 10 years or 120,000 miles from the date of first use according to Suzuki's records. If required, your vehicles right front seat cushion will be replaced by a Suzuki dealer or Suzuki service point at no cost to you for parts and labor. Please keep this letter with your other important glove box literature for future reference and future owners. Diagnosis or repairs for conditions determined to be other than B1312 DTC are not covered under this special extended coverage program. This coverage extension will not extend your basic 36 month, 36,000 mile limited warranty or the 7 year, 100,000 mile power train limited warranty.
