GRAND VITARA

Technical Bulletin

Section Title: Restraints
 TSB No. TS 06 05212R1

SUBJECT: SPECIAL COVERAGE EXTENSION “ZA”; SPECIFIC “AIRBAG”
 WARNING LIGHT ILLUMINATION (DTC B1312 ONLY).
MODEL(S): GRAND VITARA (JB424, JB627, JB632)
YEAR: 2006~2011

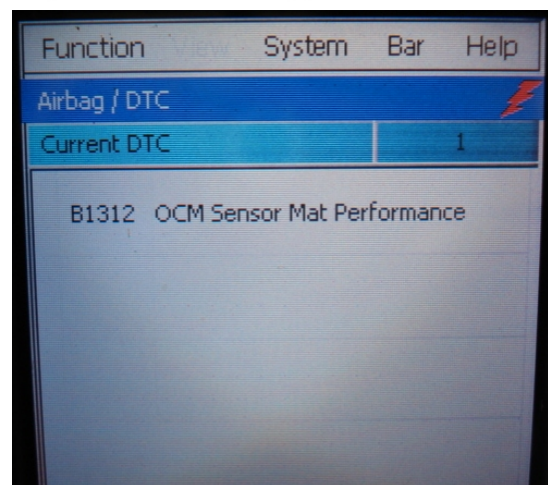
7. Confirm that DTC B1312 is a Current DTC on the SDT.
 - If DTC B1312 is Current, go to step 8.
 - **If DTC(s) other than B1312 are present in Current and or History, or DTC B1312 is present in History only, clear all DTC Codes and re-test. If DTC B1312 does not become set as a Current DTC it is not the cause of the "AIRBAG" warning light. Refer to the Suzuki Service Manual troubleshooting instructions for other DTC(s) stored and diagnose the issue.**

8. Replace front passenger seat cushion assembly with new one (Please refer to the EPC and appropriate Suzuki Service Manual for replacement of the lower seat cushion on the right front passenger seat only).
9. After completing the replacement, erase DTC using scan tool and confirm DTC Code B1312 is no longer present real time in the vehicle.
10. After clearing the "AIRBAG" DTC(s), confirm the following:
 - ✓ "AIRBAG" warning light does not remain illuminated after flashing.
 - ✓ Passenger seat belt reminder light does not illuminate when turning the ignition switch to the "ON" position.
11. The repair is complete. Return the vehicle to the customer.
