Technical Bulletin

Section Title: Restraints
 TSB No. TS 06 05212

SUBJECT: SPECIAL COVERAGE EXTENSION FOR A SPECIFIC “AIRBAG”
 WARNING LIGHT ILLUMINATION (DTC B1312 ONLY).
MODEL(S): GRAND VITARA (JB424, JB627, JB632)
YEAR: 2006~2011

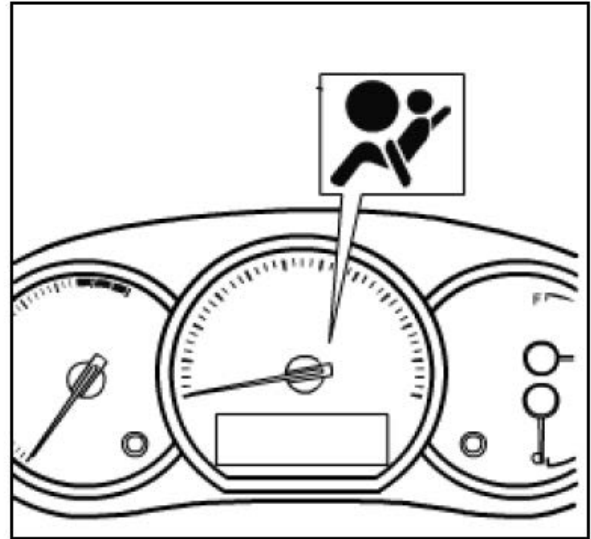
1. Check and ensure there is nothing placed or resting on the front passenger seat.
2. Turn the ignition switch to the "ON" position.
3. Check that the "AIRBAG" warning light remains on after flashing.

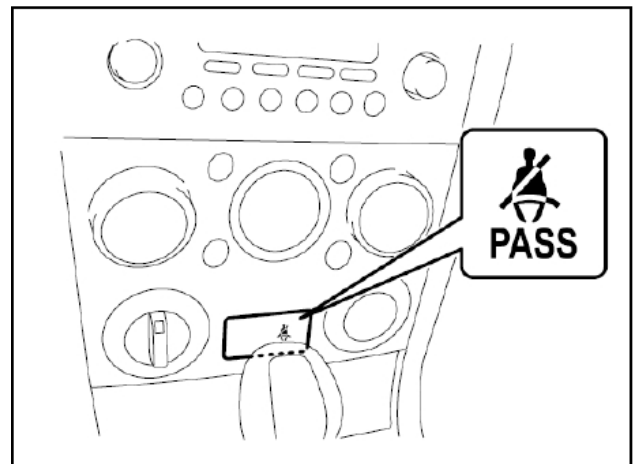
4. Check that the passenger seat belt reminder light is on (illuminated).
 - If the passenger seat belt reminder light is illuminated, go to step 5.
 - If the passenger seat belt reminder light does not illuminate, DTC B1312 is not the cause of the "AIRBAG" warning light. Refer to the Suzuki Service Manual to determine the DTC stored and diagnose the issue.

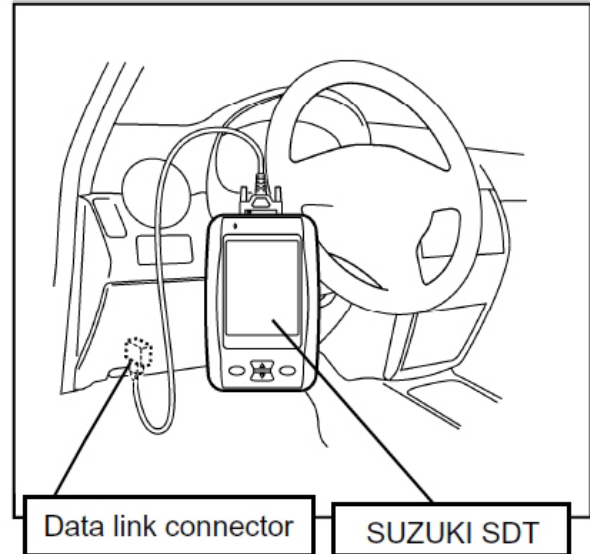
9. After completing the replacement, erase DTC using scan tool.
10. After clearing the "AIRBAG" DTC(s), confirm the following:
 - ✓ "AIRBAG" warning light does not remain illuminated after flashing.

- ✓ Passenger seat belt reminder light does not illuminate when turning the ignition switch to the "ON" position.
11. The repair is complete. Return the vehicle to the customer.

8. Replace front passenger seat cushion assembly with new one (Please refer to the EPC and appropriate Suzuki Service Manual for replacement of the lower seat cushion on the right front passenger seat only).
