# Technical Bulletin

Section Title: Restraints  
 TSB No. TS 02 05222R1

**SUBJECT:** SPECIAL COVERAGE EXTENSION “ZA”; SPECIFIC “AIRBAG”  
 WARNING LIGHT ILLUMINATION (DTC B1312 ONLY).  
**MODEL(S):** SX4 (RW420)  
**YEAR:** 2007~2011

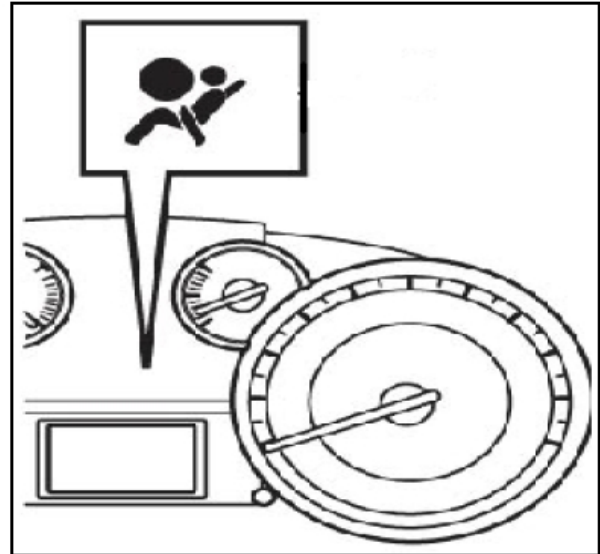
1. Check and ensure there is nothing placed or resting on the front passenger seat.
2. Turn the ignition switch to the "ON" position.
3. Check that the "AIRBAG" warning light remains on after flashing.

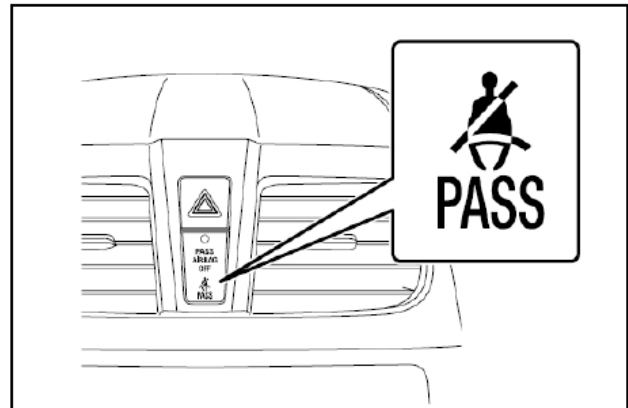
4. Check that the passenger seat belt reminder light is on (illuminated).
  - If the passenger seat belt reminder light is illuminated, go to step 5.
  - **If the passenger seat belt reminder light does not illuminate, DTC B1312 is not the cause of the "AIRBAG" warning light. Refer to the Suzuki Service Manual to determine the DTC stored and diagnose the issue.**

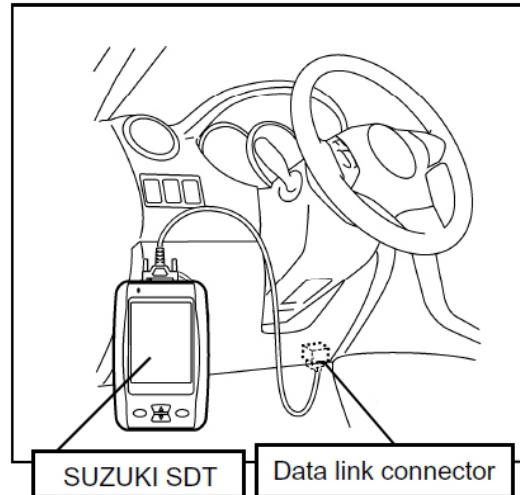
5. Connect SUZUKI scan tool (SUZUKI-SDT) to data link connector (DLC).
6. Read the DTC(s) in the "Airbag" system

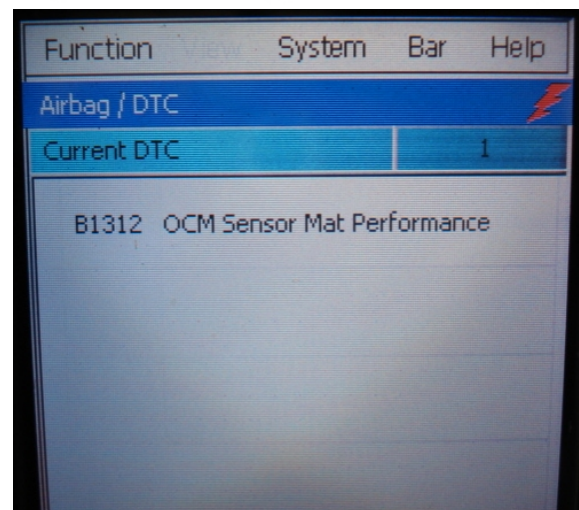
7. Confirm that DTC B1312 is a Current DTC on the SDT.
  - If DTC B1312 is Current, go to step 8.
  - **If DTC(s) other than B1312 are present in Current and or History, or DTC B1312 is present in History only, clear all DTC Codes and re-test. If DTC B1312 does not become set as a Current DTC it is not the cause of the "AIRBAG" warning light. Refer to the Suzuki Service Manual troubleshooting instructions for other DTC(s) stored and diagnose the issue.**

8. Replace front passenger seat cushion assembly with new one (Please refer to the EPC and appropriate Suzuki Service Manual for replacement of the lower seat cushion on the right front passenger seat only).
9. After completing the replacement, erase DTC using scan tool and confirm DTC Code B1312 is no longer present real time in the vehicle.
10. After clearing the "AIRBAG" DTC(s), confirm the following:
  - ✓ "AIRBAG" warning light does not remain illuminated after flashing.
  - ✓ Passenger seat belt reminder light does not illuminate when turning the ignition switch to the "ON" position.
11. The repair is complete. Return the vehicle to the customer.
