Technical Bulletin

Division: Automotive Category: Technical Section Title: Restraints TSB No. TS 02 05222

SUBJECT:	SPECIAL COVERAGE EXTENSION FOR A SPECIFIC "AIRBAG"
	WARNING LIGHT ILLUMINATION (DTC B1312 ONLY).
MODEL(S):	SX4 (RW420)
YEAR:	2007~2011

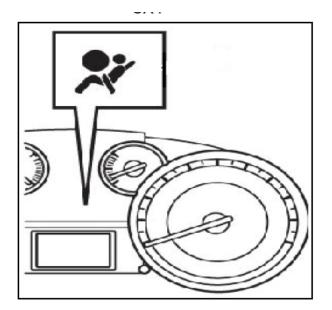
- 1. Check and ensure there is nothing placed or resting on the front passenger seat.
- 2. Turn the ignition switch to the "ON" position.
- 3. Check that the "AIRBAG" warning light remains on after flashing.
