Mack Trucks, Inc.
Greensboro, NC USA

Field Service Bulletin Trucks

Engine Variable Geometry Turbocharger (VGT) Actuator Connector Pin, Replacement

FSB 255-024, Engine Variable Geometry Turbocharger (VGT) Actuator Connector Pin, Replacement

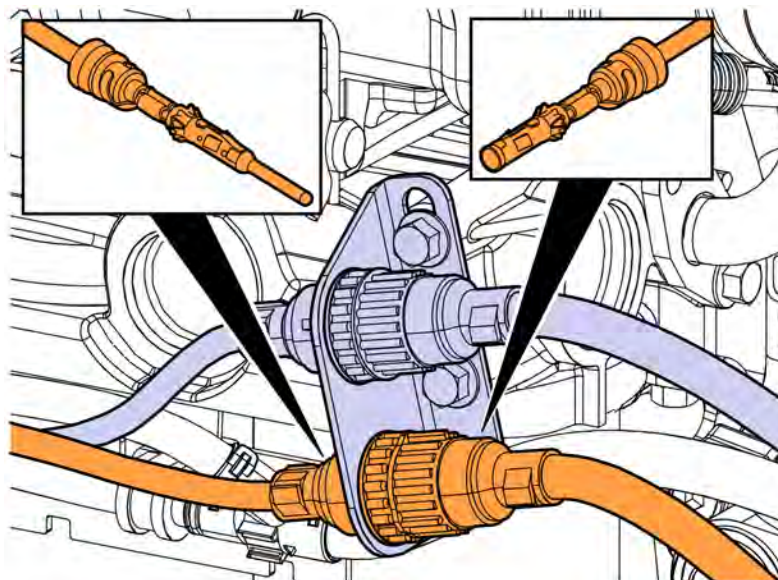
W2073530

Severe fretting damage of the engine variable geometry turbocharger (VGT) actuator harness may cause an unreliable signal to the engine VGT actuator on certain MACK CHU, CXU, GU, LEU, MRU and TD vehicles. An unreliable signal to the engine VGT actuator will generate diagnostic trouble codes (DTCs). If DTCs are logged and pin fretting is identified as the cause, the engine VGT actuator connector pin and socket contacts should be replaced. Replacement of the pin and socket contacts will eliminate pin fretting and increase the reliability of the signal to the engine VGT actuator.
