SB-10044324-8194

FSB 255-024, Engine Variable Geometry Turbocharger (VGT) Actuator Connector Pin, Replacement

(May 2012)

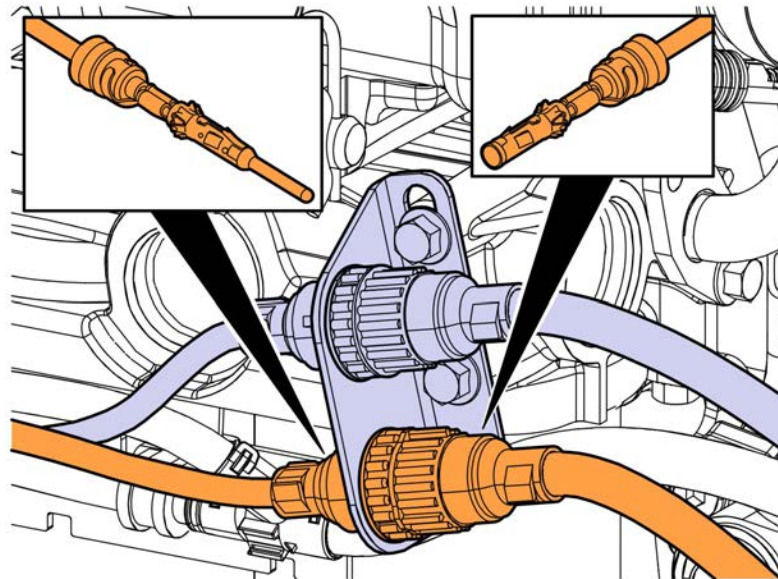
W2073530

Severe fretting damage of the Engine Variable Geometry Turbocharger (VGT) Actuator harness may cause an unreliable signal to the engine VGT Actuator on certain MACK CHU, CXU, GU, TD, LEU and MRU trucks. An unreliable signal to the engine VGT Actuator will generate Diagnostic Trouble Codes (DTCs). If DTCs are logged and pin fretting is identified as the cause, the engine VGT Actuator connector pin and socket contacts should be replaced. Replacement of the pin and socket contacts will eliminate pin fretting and increase the reliability of the signal to the engine VGT Actuator.

Connector Pin Replacement Parts			
Item #	Part Number	Description	Crimp Jaw Position
1	984945	Pin, Eng VGT Actuator Conn	B
2	3963409	Socket, Eng VGT Actuator Conn	B
3	20734499	Wire Seal, Eng VGT Actuator Conn	N/A
