**SB-10044325-5447**

### Engine Variable Geometry Turbocharger (VGT) Actuator Connector Pin, Replacement

## FSB 255-024, Engine Variable Geometry Turbocharger (VGT) Actuator Connector Pin, Replacement

(May 2012)

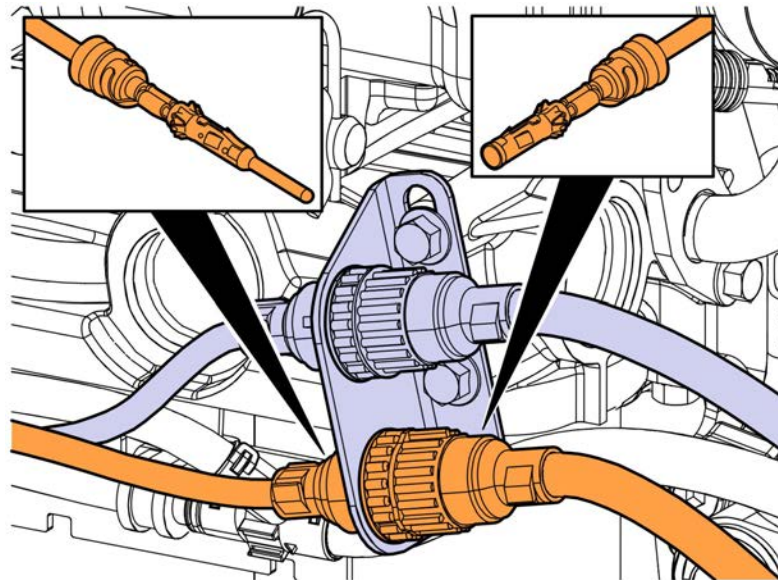
W2073530

Severe fretting damage of the Engine Variable Geometry Turbocharger (VGT) Actuator harness may cause an unreliable signal to the engine VGT Actuator on certain VOLVO VN, VHD, VT, and VAH trucks. An unreliable signal to the engine VGT Actuator will generate Diagnostic Trouble Codes (DTCs). If DTCs are logged and pin fretting is identified as the cause, the engine VGT Actuator connector pin and socket contacts should be replaced. Replacement of the pin and socket contacts will eliminate pin fretting and increase the reliability of the signal to the engine VGT Actuator.
