Engine Variable Geometry Turbocharger  
(VGT) Actuator Connector Pin, Replacement

VAH, VHD, VN, VT  
D11, D13, D16

**FSB 255-024, Engine Variable Geometry  
Turbocharger (VGT) Actuator Connector Pin,  
Replacement**

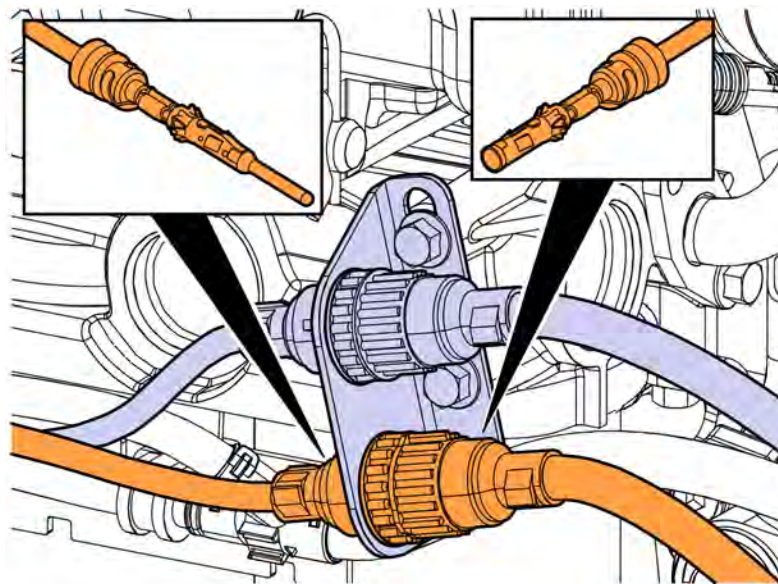
W2073530

Severe fretting damage of the engine variable geometry turbocharger (VGT) actuator harness may cause an unreliable signal to the engine VGT actuator on certain VOLVO VAH, VHD, VN and VT vehicles. An unreliable signal to the engine VGT actuator will generate diagnostic trouble codes (DTCs). If DTCs are logged and pin fretting is identified as the cause, the engine VGT actuator connector pin and socket contacts should be replaced. Replacement of the pin and socket contacts will eliminate pin fretting and increase the reliability of the signal to the engine VGT actuator.
