## Bug Screen Loosening

## VN

### FSB 261-033, Bug Screen Loosening

(May 2012)

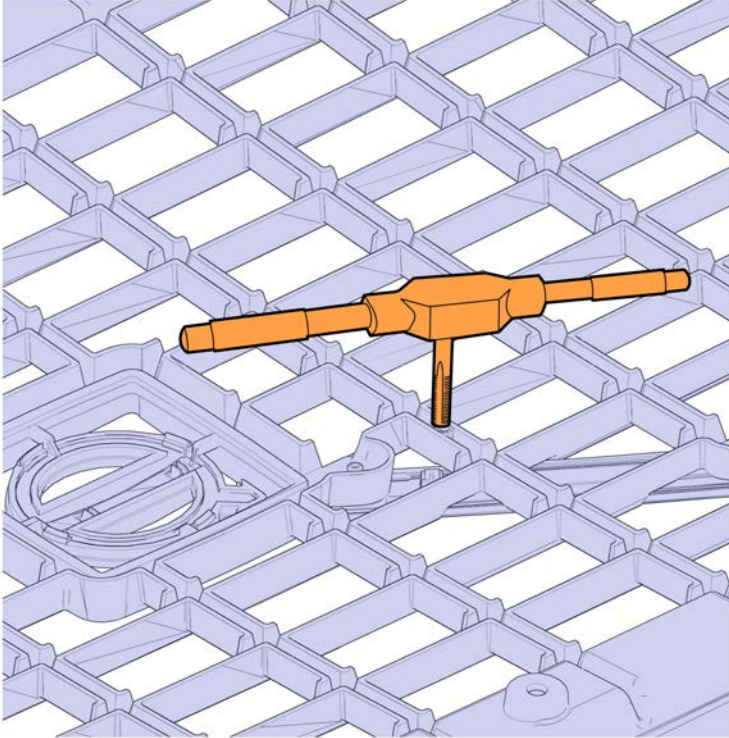
5

Certain VOLVO VN model trucks may experience bug screens loosening from the grille. This issue can occur due to retainers falling out of the grille. It has been determined that the threading of the insert in the grille may not be deep enough to provide sufficient engagement of the bug screen retainer. To resolve the issue on vehicles with missing retainers, tap a new thread in the grille and install new retainers. Use an M8 x 1.25 plug tap to create threads in the grille inserts which are deep enough to provide sufficient retainer engagement.

Using a M8 x 1.25 plug tap, tap out all six holes on the grille where the bug screen is secured. The purpose of this step is to create new threads for proper retainer retention.
