RECALL CAMPAIGN BULLETIN

ITB11-039e
 June 8, 2012

VOLUNTARY SAFETY RECALL CAMPAIGN 1997-2003 QX4 IN SALT STATES FRONT STRUT HOUSING CORROSION

CAMPAIGN ID #: R1109 **NHTSA** #: 11V-244

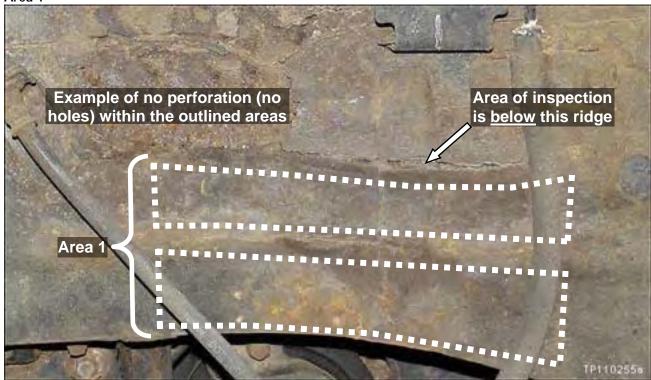
Figure 3

Area 1: Look for perforation (holes) in the metal only in the areas outlined above.

- a. Retain the vehicle at the dealer. (The vehicle is not repairable.)
- b. Supply the customer with a rental car.
- c. Fax a completed Non-Repairable Report to Morley (see page 54).

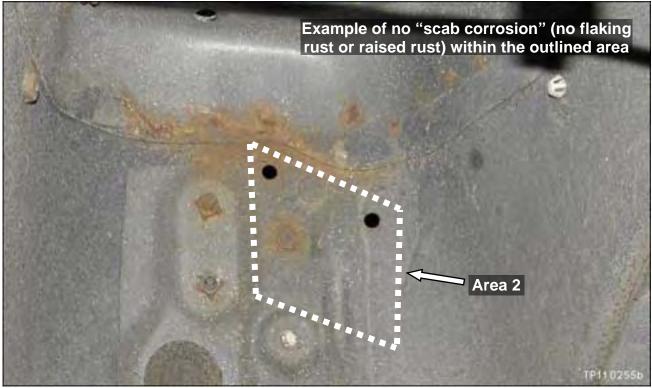
Area 2: Look for "scab corrosion" (flaking rust or raised rust) on driver side AND passenger side <u>only in the area outlined above</u>.

- The area shown in Figure 4 applies to driver side **AND** passenger side.
- If needed, refer to examples (additional photos) of Area 2 scab corrosion inspection on page 47.

- a. Retain the vehicle at the dealer. (The vehicle is not repairable.)
- b. Supply the customer with a rental car.
- c. Fax a completed Non-Repairable Report to Morley (see page 54).

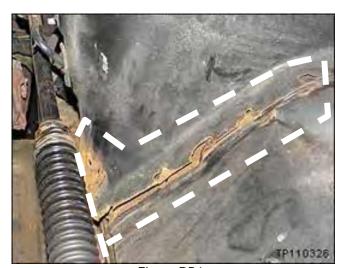
Figure RB6

7a. Only if the strut housing panel is separated as shown in Figure RB6:

Use a wire brush to clean any loose rust, paint, or other debris from the area shown with dashed line.

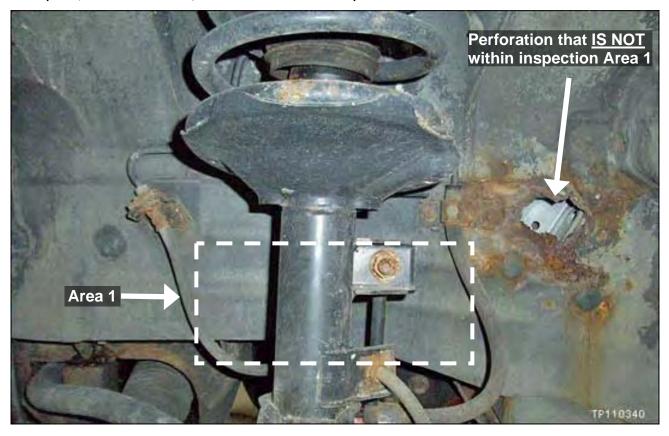
Example (Additional Photo) of Area 1 Perforation Inspection

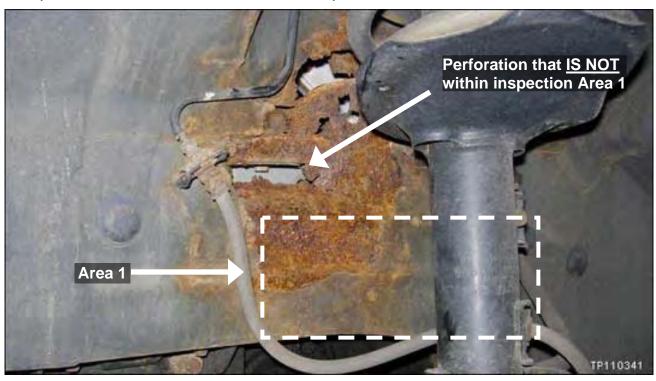
Example (Additional Photo) of Area 1 Perforation Inspection
