Engine VGT Actuator and TSS Sensor
Connector, Relocation
CHU, CXU, GU, MRU
MP8

SB-10044335-6505 PI0781, Engine VGT Actuator and TSS Sensor Connector, Relocation

(May 2012)

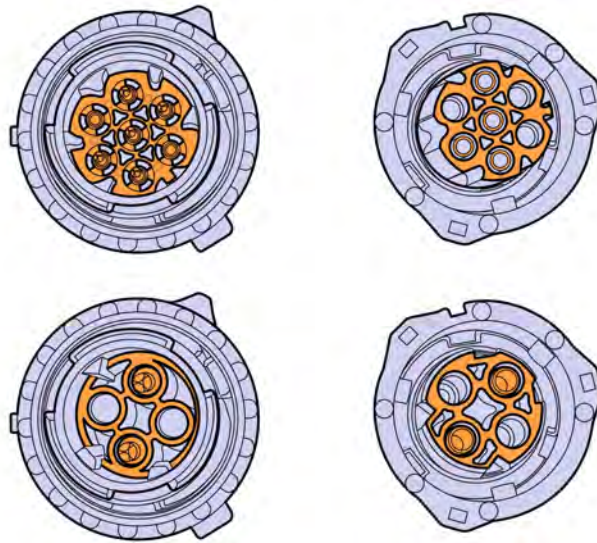
W2072325

- 7 Inspect connectors for green/brown dust on the pins or sockets.

Note: If green/brown dust is present in the areas highlighted in the figure below, clean the male and female engine VGT actuator and TSS sensor connectors with approved electrical solvent. Allow the connectors to thoroughly dry before assembly.

Note: If the Engine VGT Actuator Connector pins show signs of wear, replace the pins per "Engine VGT Actuator Connector Pin, Replacement" Field Service Bulletin PV729-FSB255-024_M (USA53616).
