Mack Trucks, Inc.
Greensboro, NC USA

Service Program Trucks

Date	Group	No.	Release	Page
6.2012	491	787	02	1(8)

PI0787, Transmission Cooler Line O-Ring

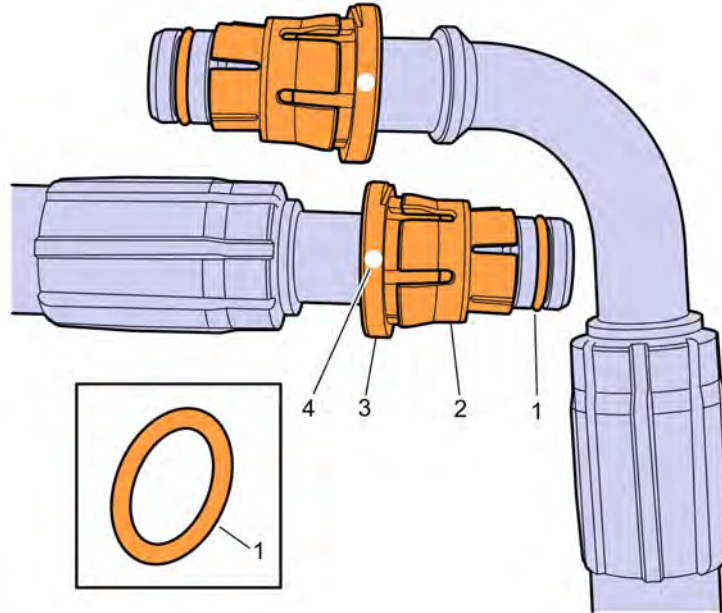
W4072905

Trucks built after March 05, 2012 were assembled with a replacement o-ring on the transmission cooler line fittings. A white dot on the shoulder of the fitting cap indicates a replacement o-ring was installed during assembly. See figure below. Visually inspect the truck for a white dot on the shoulder of the fitting cap. If the white dot is visible, only an inspection for the white dot is required. If the white dot is not visible on the fitting cap, replace the existing o-ring with a new green o-ring (part number 21866819). See the o-ring replacement procedure on page 2.

Transmission Cooler Line Fitting Components		
Item #	Part Number	Description
1	21866819	O-Ring
2	85129501	Locking Collar
3	85131659	Cap
4	N/A	Visual Inspection Mark (White Dot)

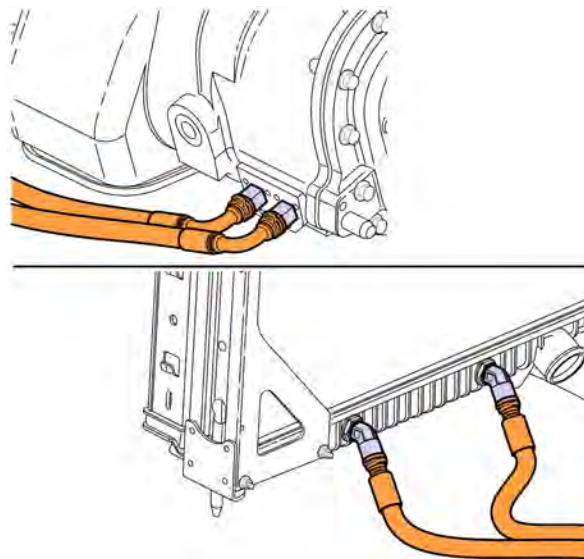
W4072906

- 1 Apply parking brake and place shift lever in neutral.
- 2 Raise hood or cab.
- 3 Disconnect all cables from the negative (ground) battery terminals to prevent personal injury from electrical shock and prevent damage to electrical components.
- 4 Inspect the transmission cooler line fittings cap for the white dot at the transmission and the radiator.

Note: If a White Dot is visible on the cap, the inspection is complete. If the White Dot is not visible on the cap, continue onto step 5 and replace the four o-rings for the radiator and the transmission fittings.
