SB-10044338-3507

Transmission Cooler Line O-Ring
CHU, CXU, GU, TD

PI0787, Transmission Cooler Line O-Ring

(MAY 2012)

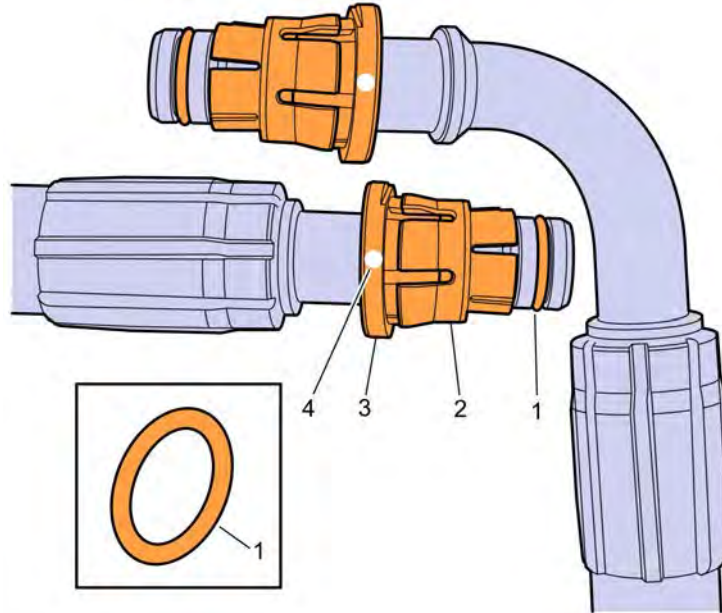
W4072905

Trucks built after March 05, 2012 were assembled with a replacement o-ring on the transmission cooler line fittings. A white dot on the shoulder of the fitting cap indicates a replacement o-ring was installed during assembly. See figure below. Visually inspect the truck for a white dot on the shoulder of the fitting cap. If the white dot is visible, only an inspection for the white dot is required. If the white dot is not visible on the fitting cap, replace the existing o-ring with a new green o-ring (part number 21866819). See the o-ring replacement procedure on page 2.

Transmission Cooler Line Fitting Components		
Item #	Part Number	Description
1	21866819	O-Ring
2	85129501	Locking Collar
3	85131659	Cap
4	N/A	Visual Inspection Mark (White Dot)

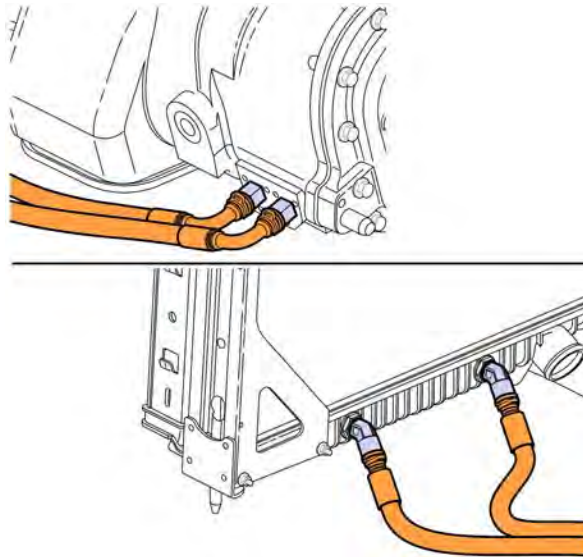
W4072906

- 1 Apply parking brake and place shift lever in neutral.
- 2 Raise hood or cab.
- 3 Disconnect all cables from the negative (ground) battery terminals to prevent personal injury from electrical shock and prevent damage to electrical components.
- 4 Inspect the transmission cooler line fittings cap for the white dot at the transmission and the radiator.

Note: If a White Dot is visible on the cap, the inspection is complete. If the White Dot is not visible on the cap, continue onto step 5.
