Technical Service Bulletin

85 Passenger floor mat is wet

85 12 06 2029243/2 May 14, 2012. Supersedes Technical Service Bulletin Group 85 number 12 – 05 dated April 23, 2012 for reasons listed below.

Model(s)	Year	VIN Range	Vehicle-Specific Equipment
Audi Q5	2009 – 2012	All	Not Applicable

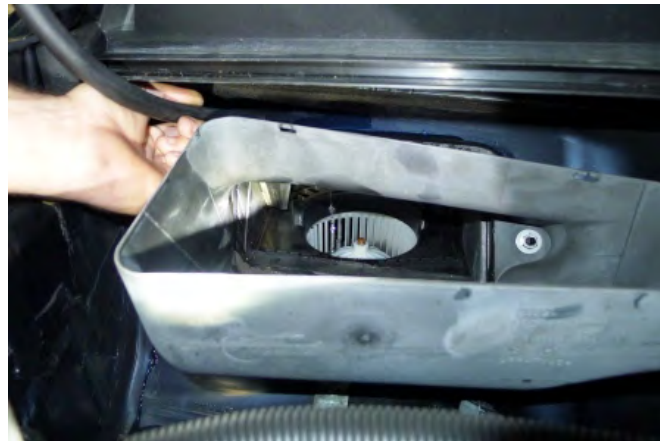
The flat surface of the fresh air intake may warp over time and cause a gap where it meets with the plenum wall. During heavy rains, water can back up and enter the vehicle through this gap.

Figure 1. Applying water through a hose to check for water leaking into the fresh air intake.

2. After the plenum cover and fresh air intake grill have been removed, and before removing the fresh air intake, verify the customer complaint by applying water to the top surface where the fresh air intake meets the plenum wall using a hose. Visually check for water leaking into the blower intake. (Figure 1).

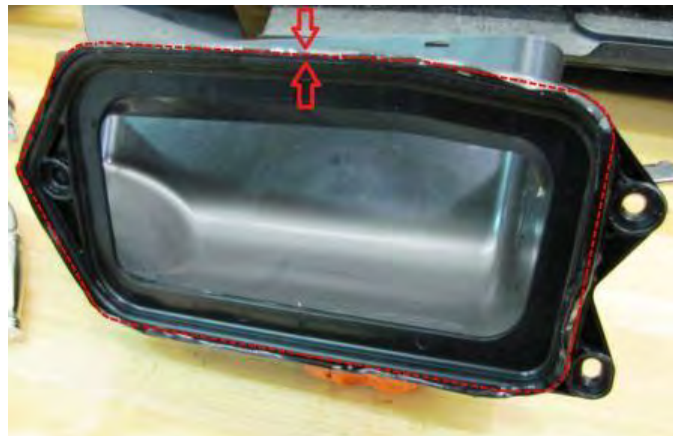
Figure 2. Location to apply the butyl cord is shown by arrows, and shown with the red dotted line.

3. Apply a bead of butyl cord around the perimeter of fresh air intake, to the outside of the existing rubber seal. (Figure 2).
