**SECTION: 417**

**Service Action: Right-Hand Rear Lamp LED Failure**

XF (X250)

VIN: R00001 - R61290  
Model Year: 2009 - 2010

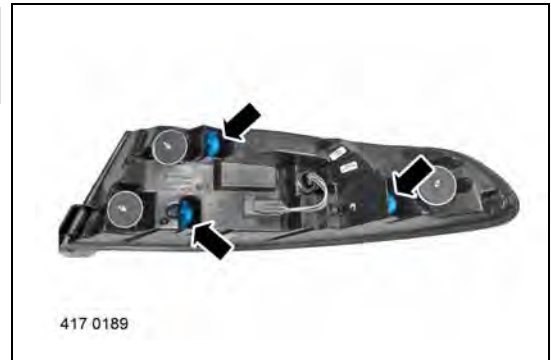
△ **NOTE: Lamps not being replaced must have the vent tubes replaced. New vent tubes are of a different material specification.**

3. Replace the vent tubes:
  - Release and remove the three (3) vent tubes from the lamp assembly.
  - Install three (3) new vent tubes to the lamp assembly.
