# Service Bulletin

Bulletin No.: PI0116B

**Subject:** Power Steering or Reduced Power Message Displayed in DIC, DTC C0475 or P2138 Set

**Models:** 2010-2012 Chevrolet Malibu

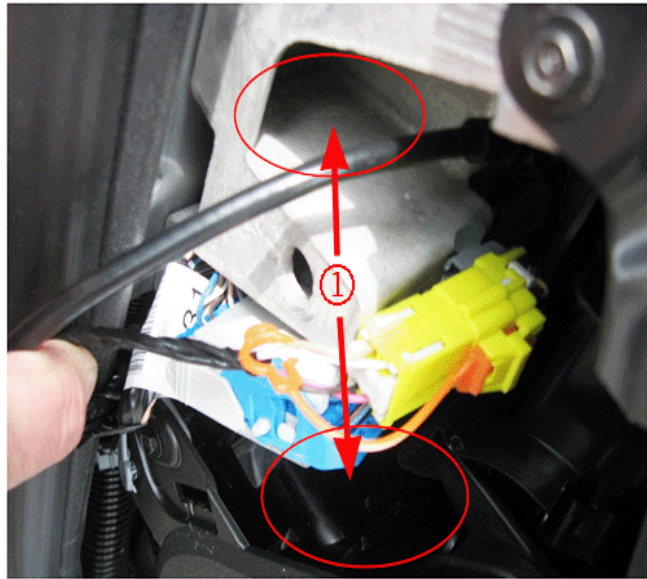
2450861

- Remove the IP outer trim cover and inspect for water/spotting within the end opening on the IP (1).

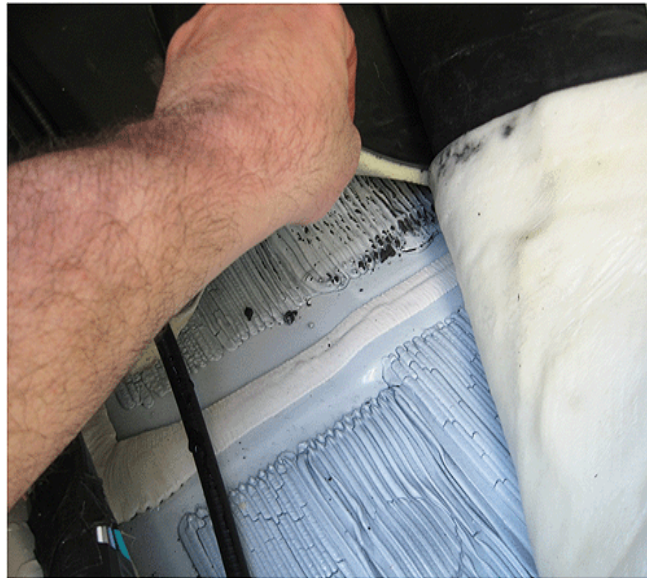
2450865

- Repositioning the front carpet, inspect for water/spotting between the carpet and the floorboard.

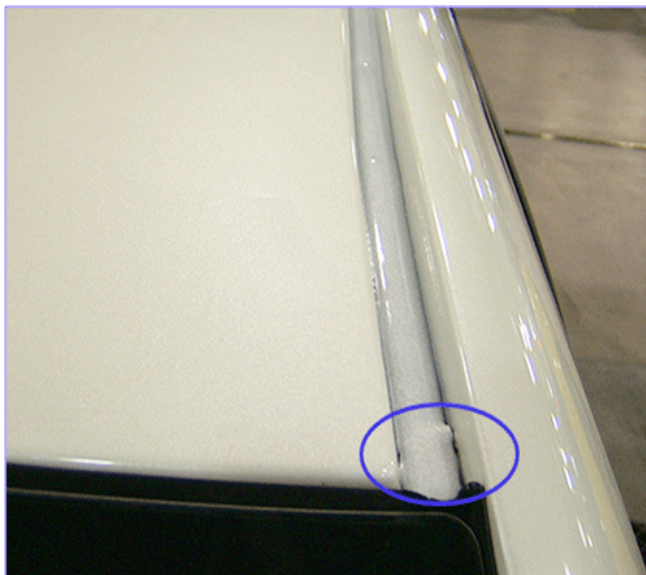
2637773

- At the windshield header and between the roof panel to A-pillar seam

**If a water leak has been identified using the above procedure, repair the water leak before repairing the EPS system or the IP to body harness interconnect X 206. Refer to PI0096A for the repair procedure.**

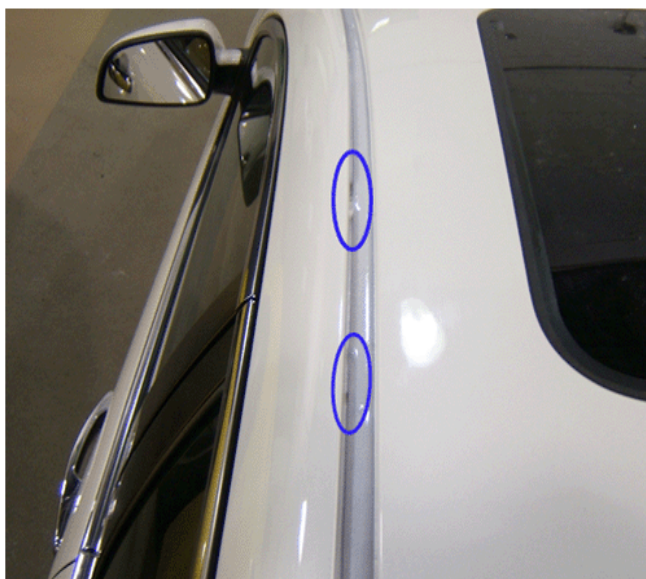
2637776

- Between the roof panel to B-pillar seam
