# Service Bulletin

**SUBJECT: Special Coverage Adjustment - Heating, Ventilation, Air Conditioning Operation - Loss of Heat**

**MODELS: 2006 Chevrolet Equinox  
2006 Pontiac Torrent**

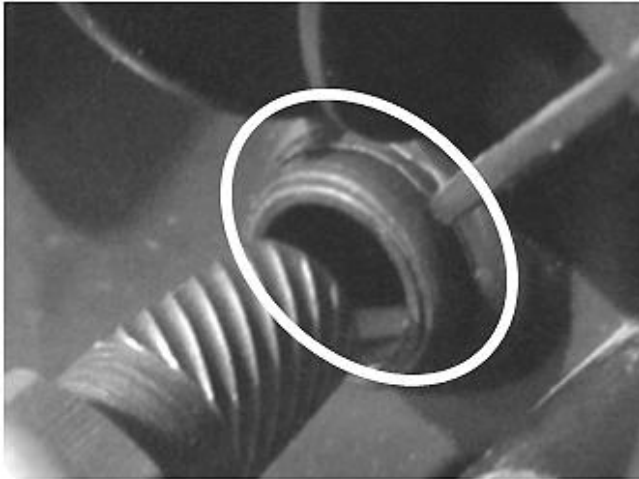
**Figure 2 – Temp Shaft Support Hole  
w/Temp Shaft Visible (Repairable)**

9. Remove the heater core cover screws (Qty 3) from the driver's side of the HVAC module. Move the cover down 2 to 4 cm (0.8 to 1.6 in).
10. Visually examine the driver's side HVAC case temp shaft support hole to verify the temp shaft is visible.

**Note:** If vehicle has the shaft present as shown in Figure 2, go to Step 11. If the vehicle has the end of the shaft missing from the case as shown in Figure 3, then refer to SI *HVAC Temperature Valve Replacement* to make the repair and discontinue use of this bulletin.

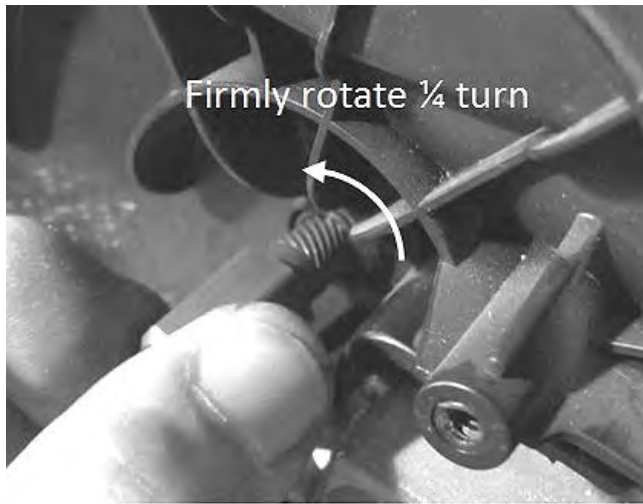
**Figure 4 – Installing Easy-Out**

**Note:** The purpose of this easy-out is to stabilize the temperature valve from falling into the case, as well as assist the technician to align the other end of the prepared shaft for attachment of the repair sleeve. It is imperative that this easy-out is installed prior to subsequent operations.

11. Carefully install the easy-out at the driver's side pivot point by slowly turning counter-clockwise until firmly engaged (approximately  $\frac{1}{4}$  turn).
12. On the passenger's side, remove the air temperature actuator screws (Qty 3) from the HVAC module.
13. Remove the air temperature actuator from the HVAC module.
14. Inspect the end of the temperature door shaft. Remove any loose door shaft pieces and discard. Confirm that the end of the shaft has in some part weakened or completely separated from the temperature control door. Gently rotating the end of the shaft should confirm this condition.

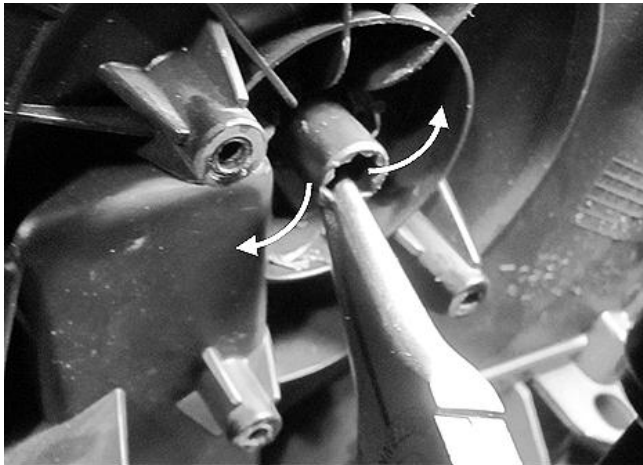
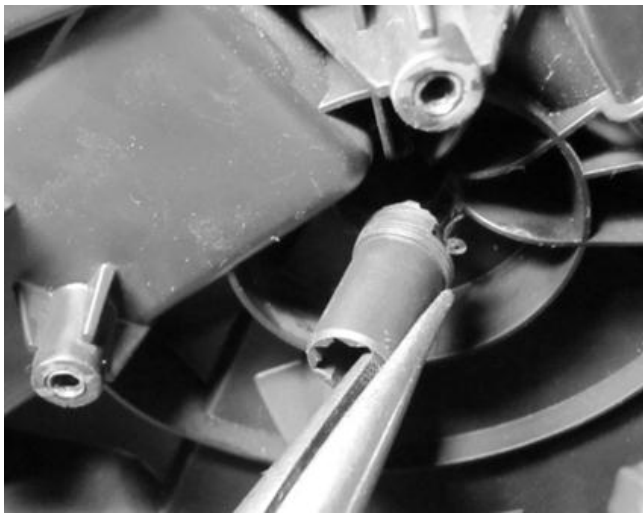
21. Inspect the temperature door shaft. If the end of the shaft is still firmly attached to the door, break the shaft with pliers using a back and forth motion. Remove the end of the shaft from the HVAC module and discard.
