Service Bulletin

Bulletin No.: PIC5657A

Subject: Condensation In Tail Lights Water In Trunk Or Spare Tire Well

Models: 2013 Chevrolet Malibu

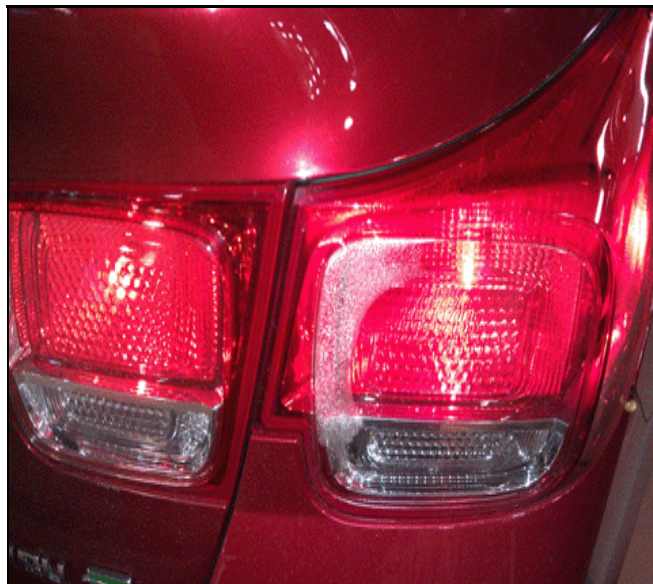
Cause: Mispositioned pressure relief valve, trunk lid liner, open seam or leaking wire harness retainer.

Correction: Check that both pressure relief valves are properly installed in openings. They should be snapped in from the outside. Check seam all around trunk opening and/or tail lamp pocket for skips in the sealer. Repair seams or reposition the pressure relief valve as needed. Check that the felt deck lid liner is not oversized and laying on the trunk opening seal when the trunk lid is closed. Check all wire harness retaining clips for signs of water intrusion and seal as needed. Clear tail light condensation by running the vehicle with park lamps on, this will by warm the lamps and clear the condensation. Photos below for reference.
