# Service Bulletin

Bulletin No.: PIP5023

**Subject:** MIL Due To DTC P0299 - Turbocharger Underboost DTC - Inspect for Turbocharger Wastegate Pivot Pin Wear

**Models:** 2011-2012 Chevrolet Cruze  
2012 Chevrolet Sonic  
With 1.4L Turbocharged Engine (RPO LUJ or LUV)

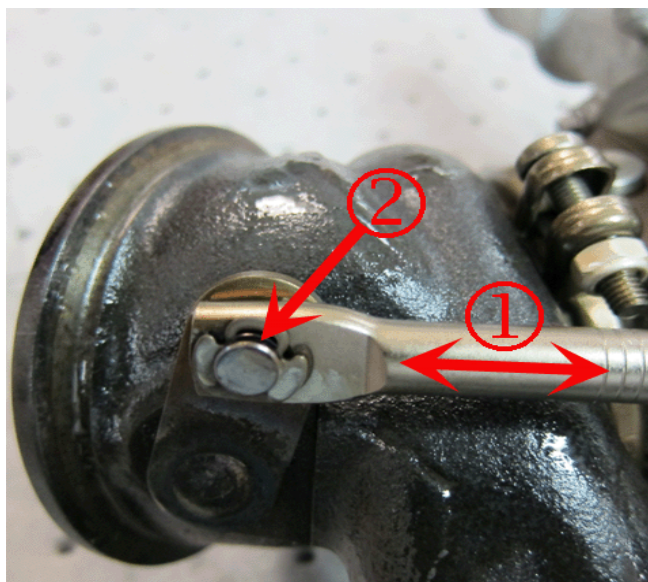
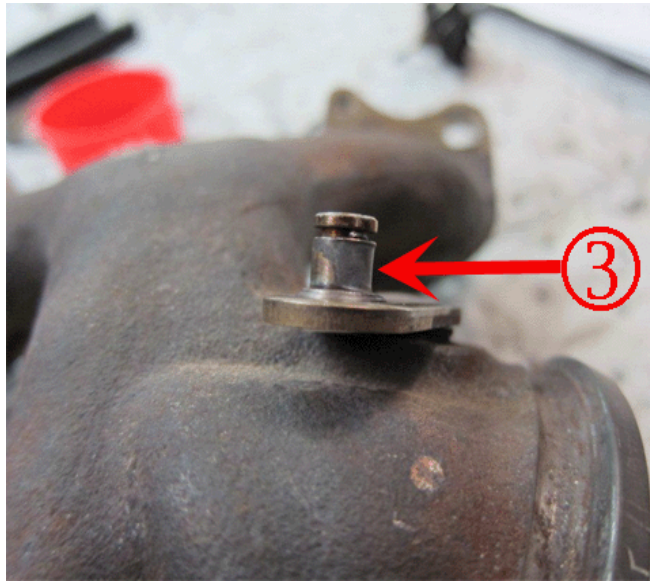
2845156

This may be the result of a worn wastegate actuator pivot pin (3), allowing the wastegate to open when it should be closed.

If a P0299 DTC is stored, perform SI diagnosis and repair as necessary. If SI diagnosis does not isolate the cause of this concern, move the wastegate linkage (1) and wastegate actuator pivot pin (2) in opposite directions while measuring the clearance between the two points. Generally, the clearance should be approximately .3-.4 mm (.012"-.016") or less. As the wastegate actuator pivot pin wears (3) and the clearance increases, the chance of setting a P0299 DTC also increases. In most cases where a P0299 DTC has set as a result of excessive clearance, it was generally around .8 mm (.032") or greater. If excessive clearance is noted, replace the turbocharger assembly and re-evaluate the concern.
