Service Bulletin

Bulletin No.: PIC5679

Subject: Power Steering Hard To Turn At Slow Speeds

Models: 2010 - 2012 LaCrosse
2011 - 2012 Regal
With Variable Assist Power Steering (RPO NV7)

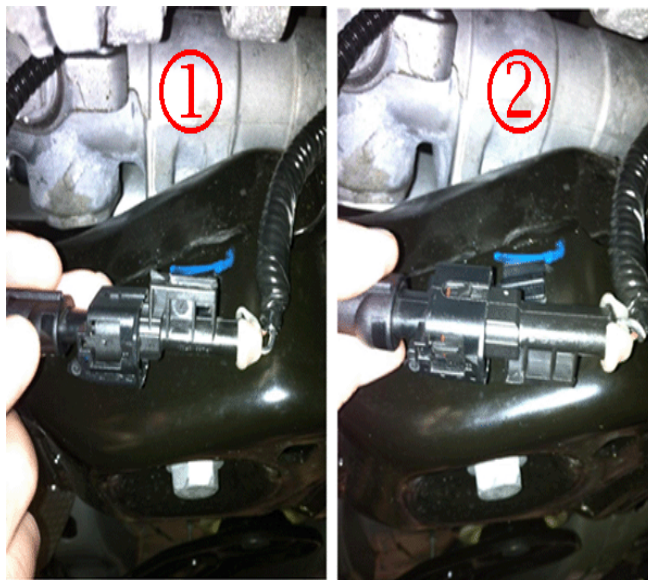
Possible variable effort power steering solenoid valve connector backward / reversed at rack and pinion connector (on frame).

1. Correct
2. Incorrect

Raise the vehicle and look at the in-line connector on the frame at the rack.

Reference the attached photo for correct and incorrect connections:
