Service Bulletin

Bulletin No.: PIP5009D

Subject: Replace The Internal Transmission Wiring Harness And TCC Enable Solenoid Anytime The Transmission Is In For Service Malfunction Indicator Lamp (MIL) With DTC P0741 Set And Harsh 1-2 Shift Built between 10/01/11 And 4/30/12

Models: 2012 Chevrolet Colorado, Express, Silverado
2012 GMC Canyon, Savana, SierraAll
Equipped with Automatic Transmission 4L60E (RPO M30)
Built between 10/01/2011 and 04/30/2012

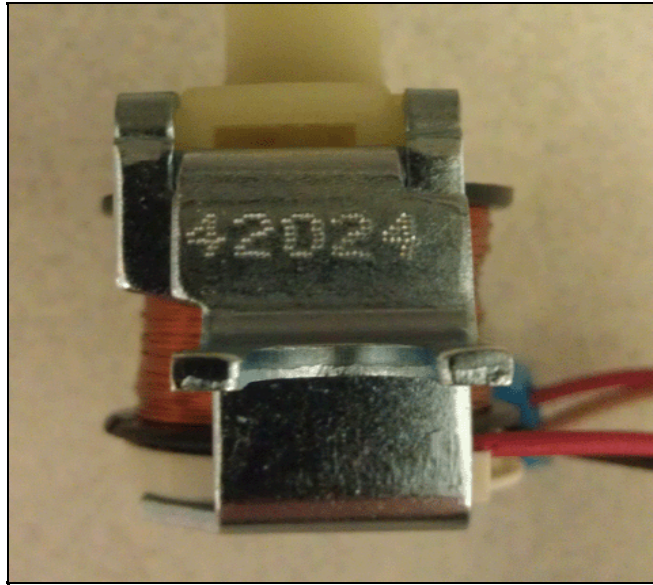
2854421

Note: To prevent multiple TCC Enable Solenoid and Wire Harness replacements check the five digit date code on the TCC Enable Solenoid body to see if it has been replaced.

The first digit (month of build) should be a 4 or higher or an alpha character. The fourth digit should be a 2 (calendar year 2012). Example: 42024 shown in the picture below.

If the first digit is a 4 or higher or an alpha character (month of build) and the fourth digit is a 2 or greater (calendar year 2012) it does not need to be replaced.

Important: Replace the TCC Enable Solenoid and Wire Harness part number 24237980 anytime repairs are being performed on the transmission on vehicles manufactured between 10/01/11 and 4/30/12.
