**NUMBER: 290120033.01****DATE: April 18, 2012****MODEL: Karma****MODEL YEAR: 2012****TITLE: False Setting of U019B - Lost Communication with Battery Charger Control Module****PRIORITY:****If vehicle exhibits the issue****APPLICABILITY:****2012 Karma****MARKET REGION:****U.S., Canada, and Europe****PURPOSE:**

# SERVICE BULLETIN

FISKER AUTOMOTIVE, INC.

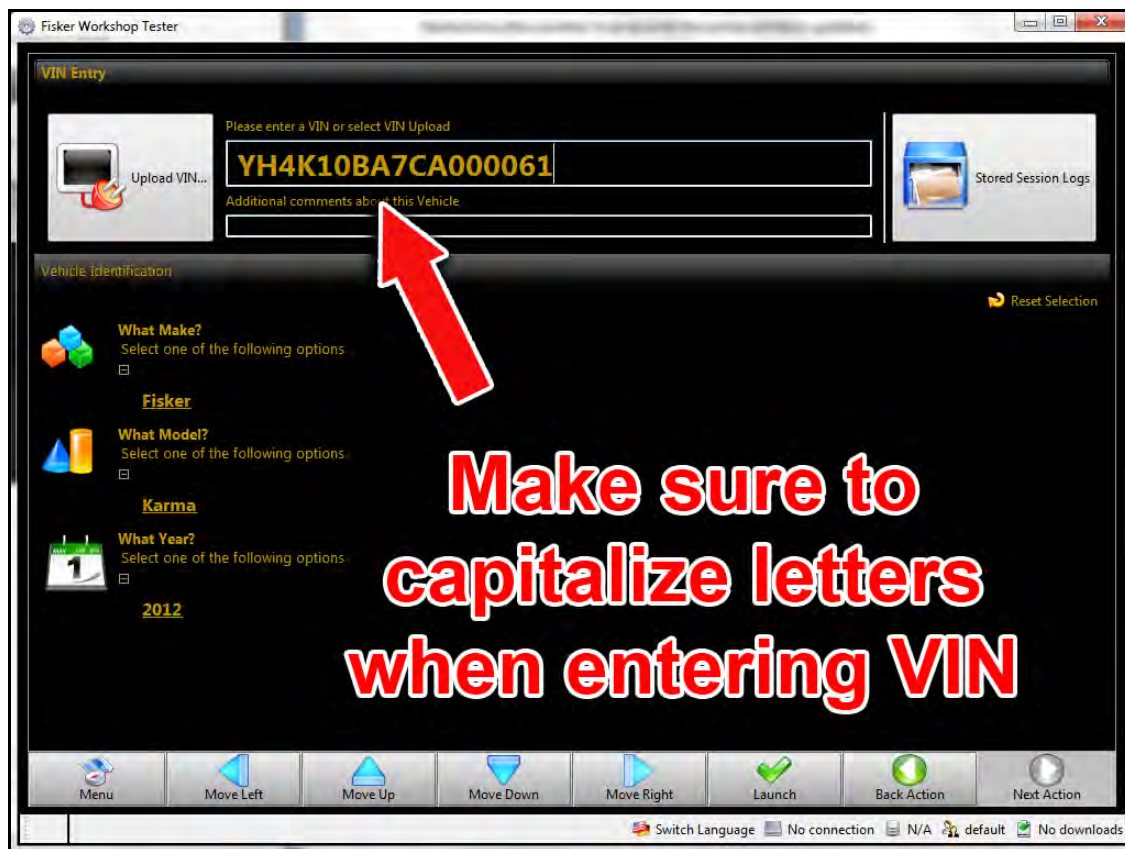
Figure 3.A

3.1. Enter the VIN number for the vehicle manually by entering it in the text box or use a Stored Session Log if the VIN has been used previously.

3.2. Verify the VIN is correct and click **Next Action** and continue to the System Navigation menu.
