SERVICE BULLETIN

AT12-005

NTB12-057

ALTIMA/SENTRA/ROGUE; CVT FAIL-SAFE CONDITION SERVICE INFORMATION

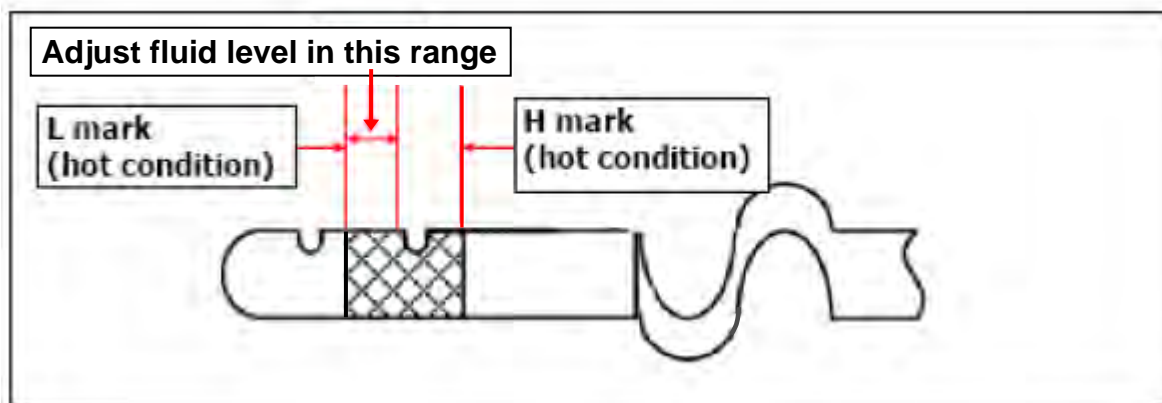
Figure 1

1. Overfilled CVT fluid level.
2. Incorrect type of transmission fluid – **Use Genuine Nissan NS-2 CVT fluid.**
3. Incorrect coolant/water mix.

- f. Adjust the CVT fluid level between the marks shown in Figure 1.

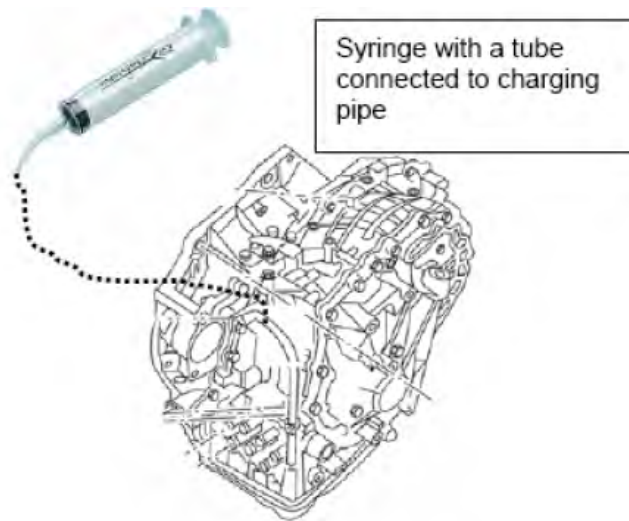
Figure 2

OK: The fluid sample is **green** in color. It may have a greenish/brown tint.

NG: The fluid sample is red in color, or any color other than a greenish/brown tint.

a. To check fluid type, draw a sample by using a syringe or suitable tool through the oil level gauge charge pipe, or drain from the oil pan (see Figure 2).

- Perform the following two times: Drain, refill with genuine NS-2 CVT fluid **only**, and then let the engine idle in Drive (with the vehicle lifted off the ground).
