Coronado
Business Class M2
> Cascadia
108SD/114SD

Freightliner
Service Bulletin

General Information

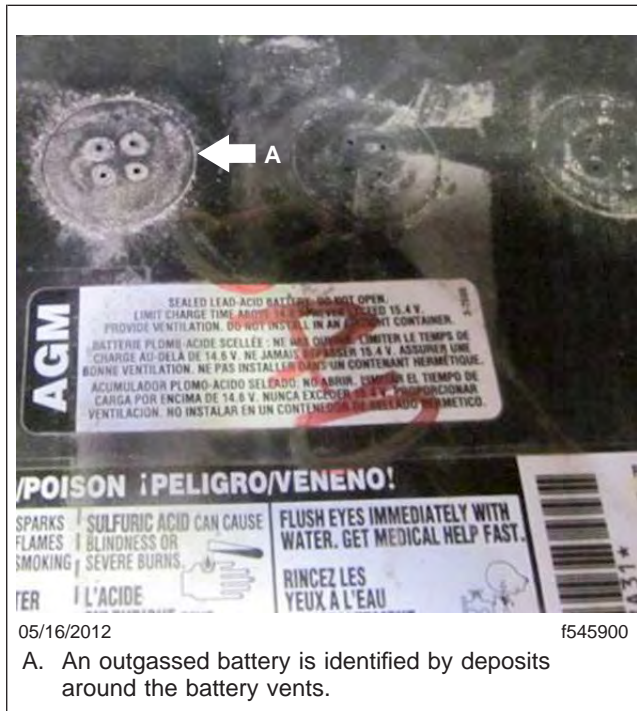
Fig. 1, Battery Outgassing

On Century Class S/T and Cascadia sleeper cabs with under-cab battery boxes built prior to February 13, 2012, 8A31 AGM batteries used for starting are failing with loss of electrolyte. While electrolyte loss is a function of normal battery use, high temperatures under the cab can accelerate electrolyte loss in 8A31 AGM batteries, which may result in early failure of the batteries. Batteries experiencing this condition frequently have bulged cases caused by outgassing (electrolyte loss), and measure well below the normal CCA (cold cranking amps). These symptoms can result in a no-start condition. See Fig. 1 and Fig. 2.

On affected vehicles **not** equipped with ParkSmart, an APU, or an inverter, the recommended replacement for the 8A31 is a 7T31, or equivalent flooded cell battery. On vehicles equipped with ParkSmart, an APU, or an inverter, the recommended replacement for the 8A31 is an AGM 9A31, or equivalent AGM battery.

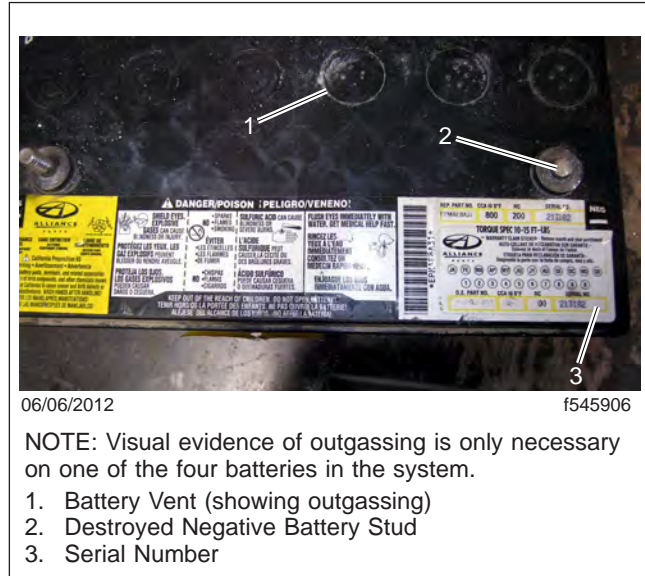
Fig. 6, Example of Photo Evidence for Warranty

NOTE: Visual evidence of outgassing is only necessary on one of the four batteries in the system.

1. Battery Vent (showing outgassing)
2. Destroyed Negative Battery Stud
3. Serial Number

Provide a single photo of each battery in the four-battery system that shows the disabled negative stud, evidence of outgassing, and the battery serial number. Serial numbers must be legible in the photos. See [Fig. 6](#).
