SB-10044699-6072

June 2012 Technical Service

Resealing the Engine Oil Pan

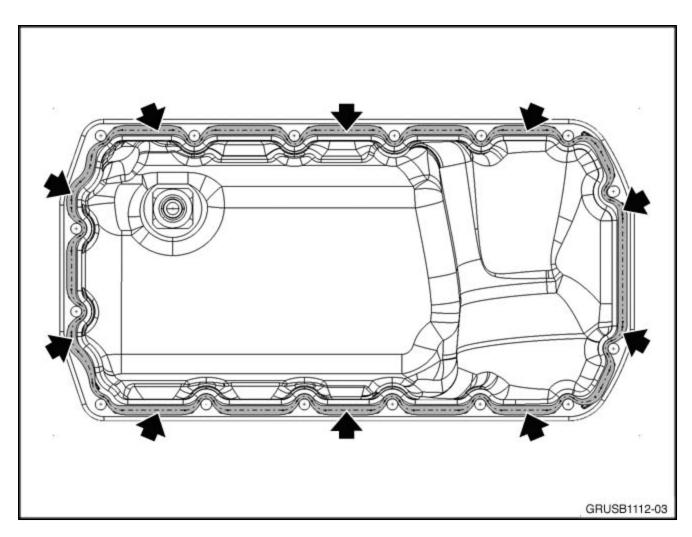
Removal of the engine oil pan can cause deformation (increased tolerances) of the sealing flange.

Apply Loctite 5970 (P/N 83 19 0 404 517) to the sealing surface of the engine oil pan. The bead of flexible liquid sealer should be approximately 2mm-2.5mm in height when applied. The sealing material should be applied to the engine oil pan on the inboard side of the drilled fastener holes. Refer to the illustration for proper flexible liquid sealer location.
