Service Bulletin

Bulletin No.: PI0742

Subject: Heated Seat(s) Intermittently Inoperative

Models: 2010-2011 Cadillac SRX
Equipped with Heated Seats (RPO KA1)

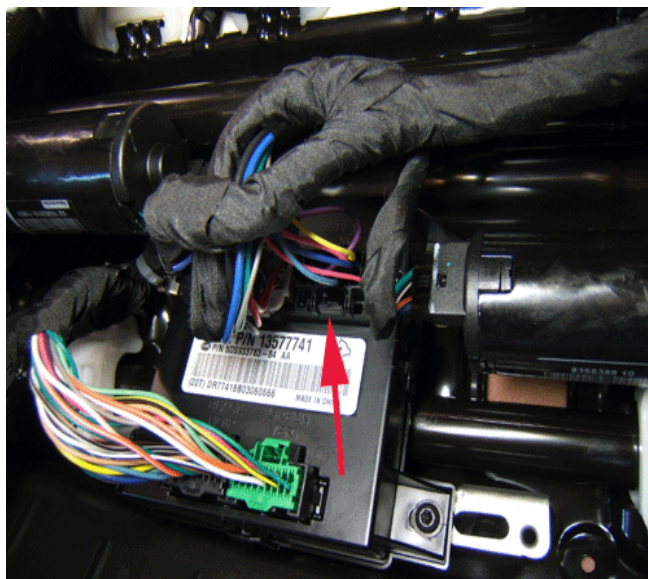
2863389

This condition may be caused by a poor electrical connection at the Seat Heating Control Module X2 connector and the module.

1. Remove the two driver seat rear mounting bolts. Refer to Driver or Passenger Seat Replacement in SI.
2. Move the driver seat back recliner position to the full forward position.
3. Disengage the two driver seat front mounting hooks.
4. Position the driver seat in the vehicle with the front of the seat assembly raised to gain access to the electrical connections for the seat heating control module.
5. Confirm the resistance values for the heated seat element(s) are within specification. Refer to Seat Heating and Cooling, Diagnostic Information and Procedures in SI.
