GROUP Engine	MODEL Sportage (SL), Forte (TD), Optima Hybrid (TF HEV) w/2.4L 2012MY
	NUMBER 119 [Rev 1], 6/29/12	DATE June 2012
<b>TECHNICAL SERVICE BULLETIN</b>		
SUBJECT: SERVICE ACTION: BALANCE SHAFT MODULE (BSM) REPLACEMENT (SA125)

SERVICE ACTION: BALANCE SHAFT MODULE (BSM) REPLACEMENT (SA125)

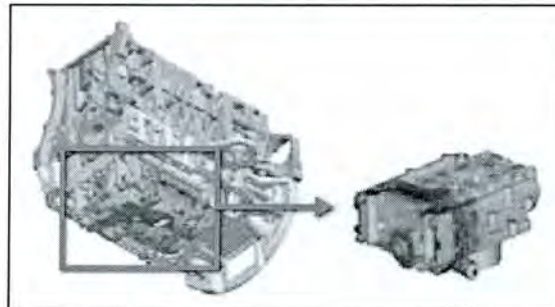
*Balance  
Shaft  
Module  
(BSM)*

This bulletin provides information relating to some Sportage, Forte, and Optima Hybrid vehicles with 2.4L engine produced from April 9, 2012 to April 20, 2012 that might experience a whistle noise emanating from the Balance Shaft Module (BSM) when engine is at operating temperature and at 2000 RPM. To correct this condition, replace the BSM following the Service Procedure below. Kia is requesting the completion of this Service Action on all affected Sportage, Forte, and Optima Hybrid vehicles prior to delivery. Before conducting the procedure, verify that the vehicle is included in the list of the affected VINs.

Replace the Balance Shaft Module (BSM) with the new part following the applicable Service Procedure on KGIS (Engine Mechanical System - Lubrication System - Oil Pump) and the timing mark information on page 3.

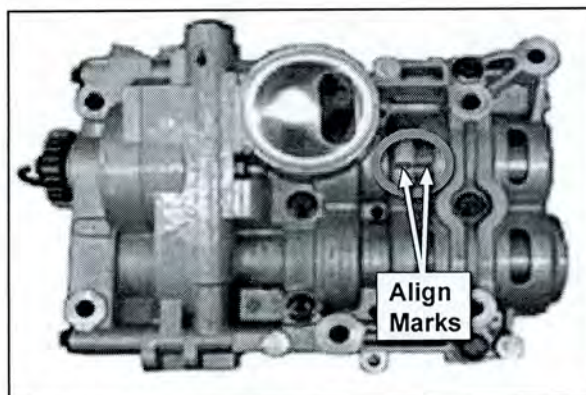
*Optima (HEV) version shown above, refer below for Forte/Sportage.*

**Record existing timing mark positions (phasing) before disassembling BSM/oil pump timing chain.** Timing mark position indicators may vary depending on engine design or date of production, and not all variants may be correctly shown or referenced in service documentation.

If new BSM/oil pump was inadvertently rotated, re-align marks by rotating the gear up to 5 revolutions to re-establish correct phasing before installing the timing chain.

1. Confirm the balance shaft & oil pump module timing marks. Timing marks to be visually aligned with centers of adjacent cast timing notches (see arrow).
2.
  - a) Install/tighten the bolts in numerical order as shown, with seating torque of 21.7 lb-ft. (29.4 Nm).
  - b) Loosen the bolts in reverse order (6- 5-4-3-2-1).
  - c) Tighten the bolts in specified order in same increments as shown on the right.
