# Field Service Bulletin Trucks

## Radiator Tie Rod Bracket

LEU  
Cummins ISL-G

### FSB 261-034, Radiator Tie Rod Bracket

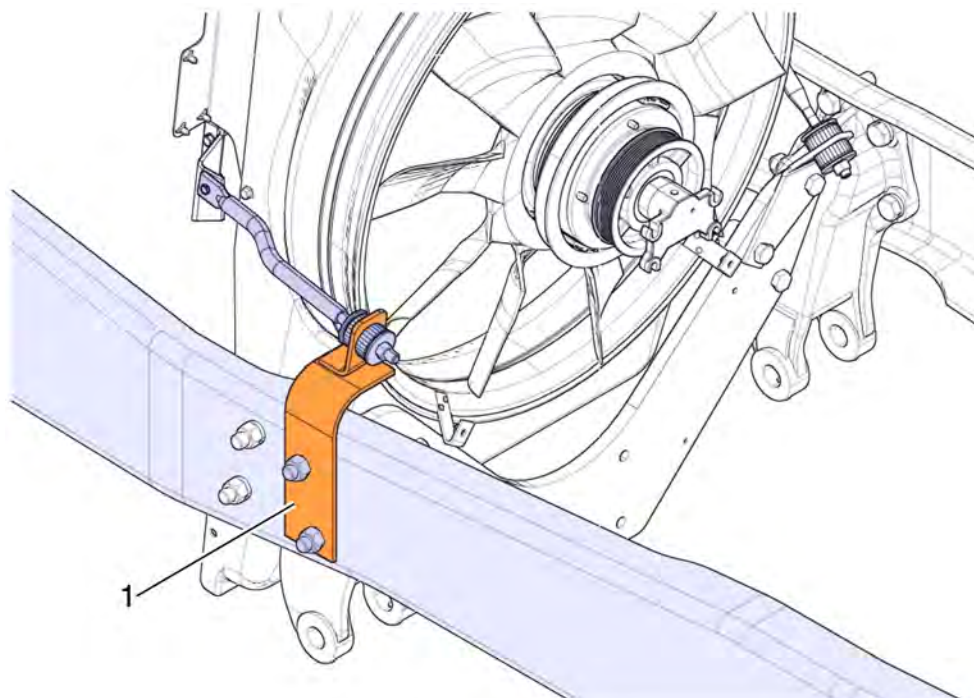
W2074786

The radiator tie rod bracket (left side) on Mack LEU trucks equipped with Cummins ISL-G natural gas engines have the potential risk of making contact with the bottom of the cab. Engineering has released a new bracket that will provide the necessary clearance between the radiator tie rod bracket and the bottom of the cab. This Field Service Bulletin (FSB) will provide the correct replacement procedure for the new radiator tie rod bracket.
