**Mack Trucks, Inc.**  
Greensboro, NC USA

# Field Service Bulletin Trucks

Four Way Flasher ABS Fault  
CHU, CXU, GU, TD

## FSB 372-011, Four Way Flasher ABS Fault

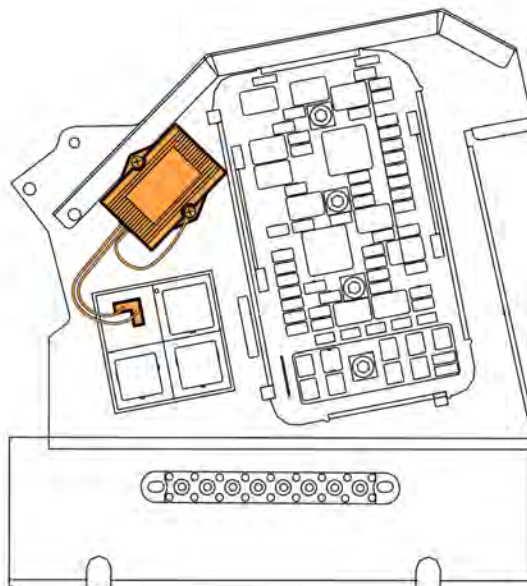
W3064625

Certain vehicles equipped with a Webb Solid State flasher, built from Jan. 1, 2010 to June 29, 2012 may experience an active ABS fault when the 4 Way flasher is enabled. It was determined that the flasher when first enabled can create unwanted voltage spikes or transients that may cause the ABS to issue a fault code and enables ABS telltale in the instrument cluster. Once the flasher is turned off, the fault codes and ABS telltale are turned "OFF" and go inactive. If this issue is found follow the procedure to replace the flasher.

| Description | Part Number |
|---|---|
| Trucklite Ultra Flasher | 25171144 |
