Door cannot be closed/not engaging

Topic number	LI72.10-P-053599
Version	1
Design group	72.10 Front door
Date	06-27-2012
Validity	197.377
Reason for change	
Reason for block

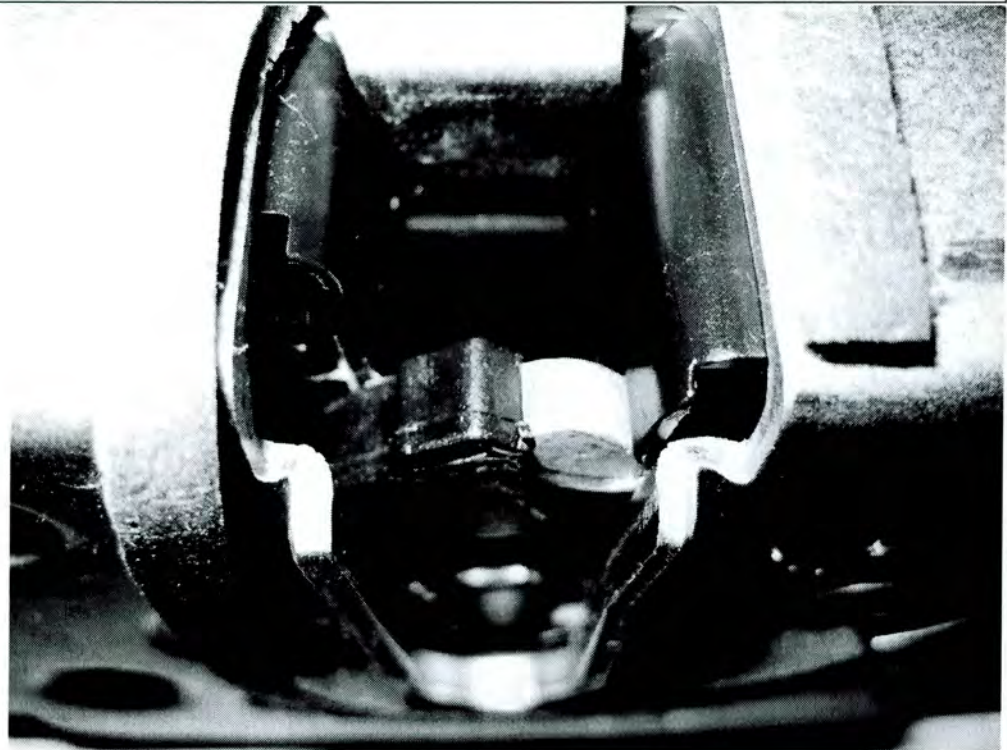
Bild 1.JPG:

Door cannot be closed/intermittently not engaging.

Plastic covering on rotary tumbler of door lock damaged/torn.

- Move lock to pre-lock position (1st detent) (see Figure 1)
- Cut all round plastic covering of rotary tumbler using a sharp knife (see Figure 2-4). Run the knife along the side of the lock housing as a guide
