SERVICE BULLETIN

APPLICABILITY: 2010MY Outback

Sunroof Binds When Opening

NUMBER: 12-122-10R

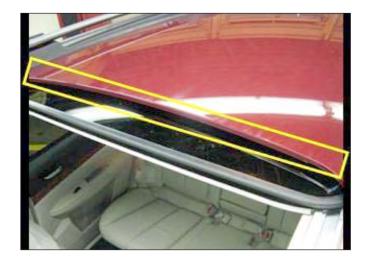
C) Review flange area for a more pronounced transition area.

2) Use available indicators listed above to determine focus area for finessing the flange.

Note: At times there may be no visual indicators or the sunroof will not open due to binding. In those cases, a general working of the flange all the way across will be required.

Caution: Move the flange in small increments to avoid cracking the paint.

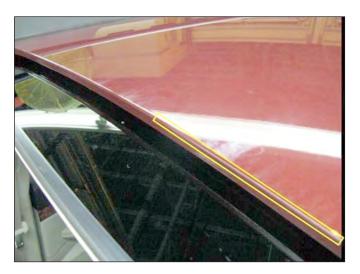
Note: Marks in the paint may be left by the plastic block. This cannot be avoided at times even with the best positioning of the plastic block.

3) Keep the block perpendicular to the flange vertical surface with the contact on the lower half of the flange. Keep the angle of attack as low as possible (pictured below).

- 4) Take your time re-checking the function of the sunroof as you go. Do not move the flange any farther than is required to restore the function of the sunroof. Reason being, there is always a risk of cracking the paint when modifying a finished panel.
- 5) Once the sunroof function is improved & the modification of the flange is completed, inspect the rear radius of the sunroof opening very carefully for cracks. Any cracks regardless of size will require the roof to be repainted.
