Technical Service Bulletin

94 Rear side marker light inoperative in lower rear bumper

94 12 78 2029782/1 June 4, 2012.

Model(s)	Year	VIN Range	Vehicle-Specific Equipment
Audi Q5	2010 – 2013	All	Not Applicable

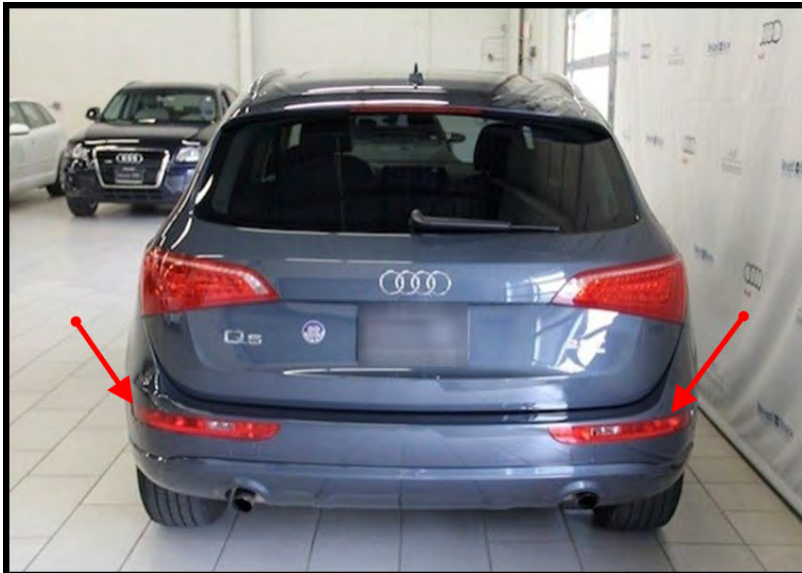
Figure 1. Rear side marker lights.

A bulb out warning is active in the instrument cluster's driver information system display and one or both of the rear side marker lights are burnt out.

Moisture and debris can enter into the lower taillight housing causing one or more of the bulbs to burn out.

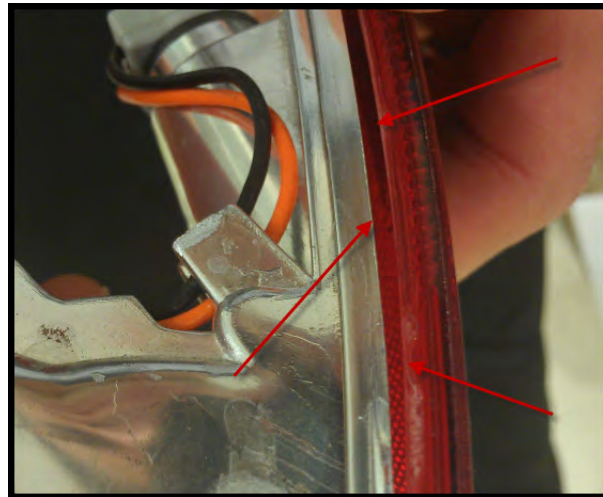
1. Uninstall both lower rear taillight housings.
Inspect the lens for any separation around the edge of the taillight lens (Figure 2).

Figure 2. Taillight Lens separation.

2. If there is any separation at all then please replace the complete taillight housing. Keep the good bulbs and any wiring, and only replace the housing and any burnt out bulbs.
Inspect the bulb holders for corrosion and debris. Repair and clean as necessary.
Please indicate to the parts manager the part should not be scrapped. An automatic system request to send back the taillight housing to AoA will be performed once the warranty claim is processed.
