# Service Bulletin

Bulletin No.: PIP4735C

**Subject:** Coolant Leak From Oil Cooler Hose Fitting On Left Side Of Engine Block

**Models:** 2009 - 2012 Chevrolet Corvette ZR1  
2010 - 2012 Chevrolet Camaro SS, ZL1

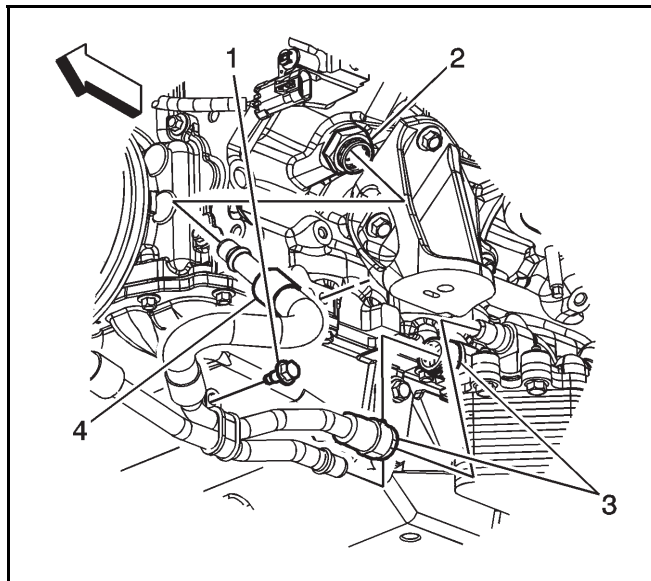
2142312

Some customers may complain of a coolant leak at low mileage. In most cases, this leak is noticed during the Pre-Delivery Inspection at the dealer. Upon inspection, the technician will find that the leak is coming from the threads of the Oil Cooler Fitting that screws into the left side of the engine block (Item #2 Below). This is most likely the result of the fitting being cross threaded into the engine block.

1. Remove the fitting. If the fitting has been cross threaded, it may take some patience and force to remove the fitting. The fitting has a normal right-hand thread but at first, it may not move, or may have minimal movement. Generally, you will have to work the fitting back and forth for several minutes. In some cases, it may help to remove other components, such as the exhaust manifold, etc., to gain better access to the fitting.
2. Inspect the fitting and the threaded hole in the engine block to see if the threads are damaged due to the fitting being cross threaded into the block.

3. If minor thread damage is found, you may be able to drag a smaller tap, such as an M10x1.25, around the inside diameter of the hole to clean up the existing threads so it is not necessary to tap the hole. If this will not work due to major thread damage, it will be necessary to tap the hole with an M28x1.25 6H bottoming pipe tap. Generally, this size is only available from suppliers who make custom taps. Here is one supplier that has been successfully used by other GM dealers:

4. Install a new oil cooler coolant fitting using the part number listed in the GMSPO catalog and the Engine Block Plug Installation Procedure in SI. As mentioned in the procedure, torque the new fitting to 50 N·m (37 lb ft).
5. Follow SI procedures to reassemble, fill the cooling system, and check for leaks.
