Service Bulletin

Bulletin No.: PIP5031

Subject: Slip Condition In 3rd Or 4th - Damaged 3-4 Clutch DTC's P0716 And P0717 May Be Set

Models: 2012 Chevrolet Colorado, Express, Silverado
2012 GMC Canyon, Savana, Sierra
Equipped with a 4L60E Automatic Transmission 4L60E (RPO M30)

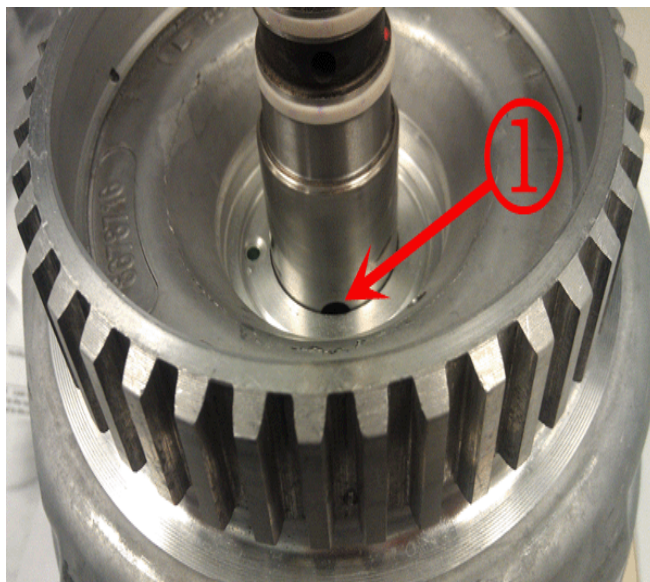
2865982

The 4L60E automatic transmission may experience a condition of slipping, late or missed shifts in 3rd and 4th gears. An internal transmission disassembly may reveal the 3-4 clutch being distressed. Upon further investigation the technician may find the turbine shaft is moving in the input housing (see picture below) allowing a loss of fluid pressure in the 3-4 clutch. The ISS teeth may move far enough out of position to cause the signal to drop out causing codes P0716 and P0717 to set.

1) 3-4 clutch feed hole.

Note: If the 3-4 clutch feed hole (call out 1) is visible the turbine shaft is moving in the input housing and the input housing needs to be replaced.

It is recommended to install a new input housing to address this concern.
