To: Area Managers
From: Don Fordiani - National Field and Dealer Operations Manager
Subject: Limited Service Campaign (LSC) CLC
Early 2013 Model Year GS 350 Vehicles
Heating, Ventilating, and Air Conditioning (HVAC) System Update

Lexus is initiating a Limited Service Campaign (LSC) CLC to update the air conditioner ECU with a new calibration in certain early 2013 model year GS 350 vehicles.

TECHNICAL INSTRUCTIONS
FOR
LIMITED SERVICE CAMPAIGN CLC
AIR CONDITIONER ECU REFLASH
EARLY 2013 MODEL YEAR GS350

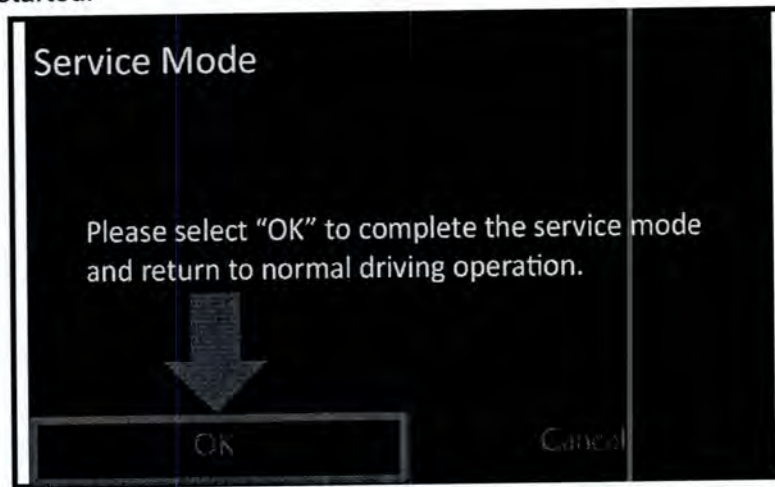
NAVIGATION SYSTEM STATUS CONFIRMATION

After completing the reflash the navigation system will be in 'Service Mode'. To remove the system from 'Service Mode', follow these steps.

NOTE: If these steps are not followed, or cancel is selected, the vehicle will return to 'Service Mode' every time the vehicle is restarted.

- Disconnect Techstream.
- Turn vehicle off.
- Turn vehicle on.
- After initializing, the navigation screen will indicate service mode. Select OK.

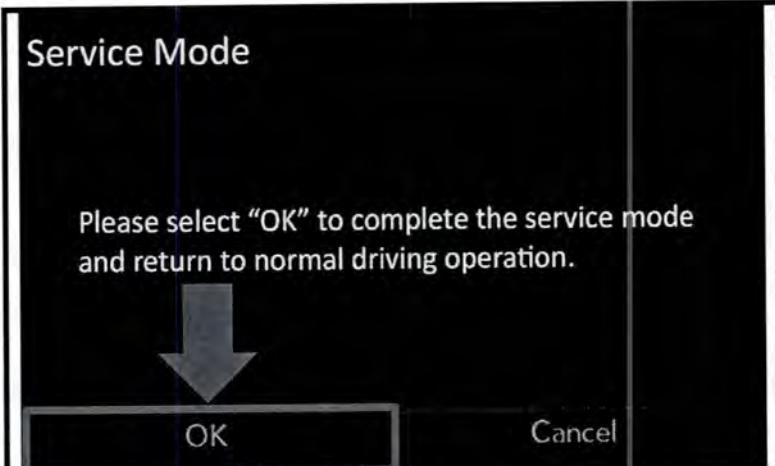
| NAVIGATION SYSTEM STATUS CONFIRMATION |

| NAVIGATION SYSTEM STATUS CONFIRMATION |
|--|
| <p>After completing the reflash the navigation system will be in 'Service Mode'. To remove the system from 'Service Mode', follow these steps.</p> <ol style="list-style-type: none"> a) Disconnect Techstream. b) Turn vehicle off. c) Turn vehicle on. d) After initializing, the navigation screen will indicate service mode. Select OK. <p>NOTE: If these steps are not followed, or cancel is selected, the vehicle will return to 'Service Mode' every time the vehicle is restarted.</p> <div style="text-align: center;"> </div> |
