Engine VGT Actuator and TSS Sensor
Connector, Relocation
CHU, CXU, GU, MRU
MP8

PI0784, Engine VGT Actuator and TSS Sensor Connector, Relocation

(June 2012)

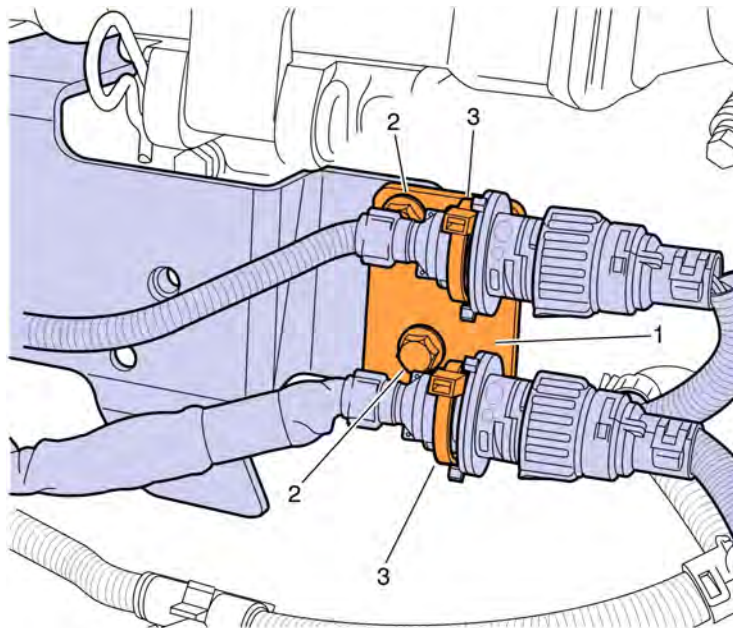
W2072321

A new campaign is available to prevent engine diagnostic trouble codes (DTCs) and missing signal from the Engine Variable Geometry Turbocharger Actuator (Engine VGT Actuator) on MACK MP8 US2010 engines with an Allison transmission. This condition is caused by fretting of the connector pins in the engine VGT actuator connector. Relocation of the engine VGT actuator connector and a new mounting arrangement has been developed to eliminate this condition. See the table below for the list of parts required for this campaign.

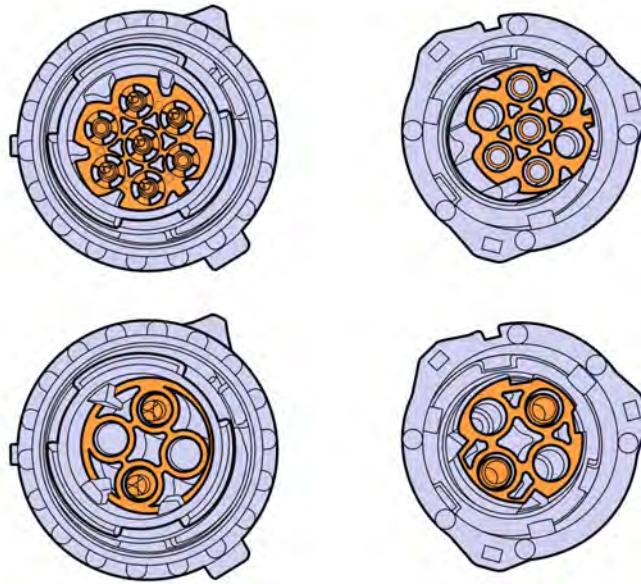
W2072325

- 7 Inspect connectors for green/brown dust on the pins or sockets.

Note: If green/brown dust is present in the areas highlighted in the figure below, clean the male and female engine VGT actuator and TSS sensor connectors with approved electrical solvent. Allow the connectors to thoroughly dry before assembly.
