**SB-10045240-4449**

## Technical Information Bulletin

**E055**

PACCAR MX Engine Turbo Oil Blow-by

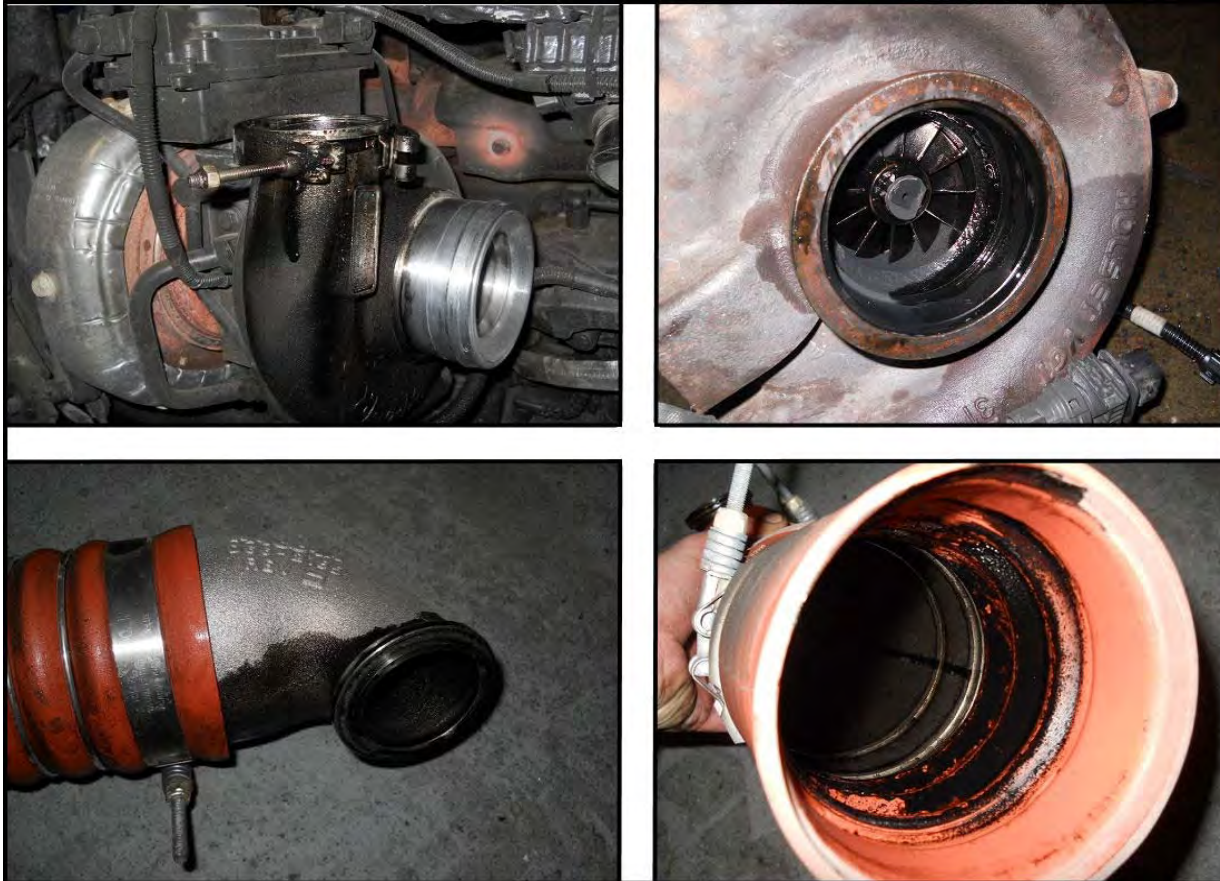
In certain operating conditions and for PACCAR MX Engines equipped with software prior to April 20, 2012, turbocharger operating speeds may create an imbalance of pressures between the turbo bearing housing and the turbocharger compressor housing. Low turbo speeds create low pressure and higher pressure in the bearing housing can result in oil being pushed past the turbo seal and into the air intake piping, and possibly into the charge air cooler. In most cases, this does not indicate that the internal seals have failed.

Evidence of oil at the turbocharger discharge is not an indication of a defect that requires turbocharger replacement.

Examples of oil by-pass related to pressure differences:

1. Tighten the hump hose clamps on all joints to 115-120 in-lb.
2. Clean oil deposits from the pipe and joint surfaces.
3. Return the truck to service

1. Remove the piping from the CAC tank
2. Use a dip tube in the CAC tank to measure captured oil.
  - a. If less than one inch of oil is measured, continue to step 3. It is not recommended that the CAC be cleaned unless there is a check engine light or there is an engine malfunction beyond the symptoms of leakage.
  - b. If more than one inch of oil is measured, clean the CAC, then continue to step 3

3. Clean all piping joints and tighten the hump hose clamps 115-120 in-lb.
4. Return the truck to service
