SB-10045282-9049

SI B11 07 12
EngineJuly 2012
Technical Service**SUBJECT****N63 Engine: Oil Consumption and/or Rough Running Complaints****MODEL**

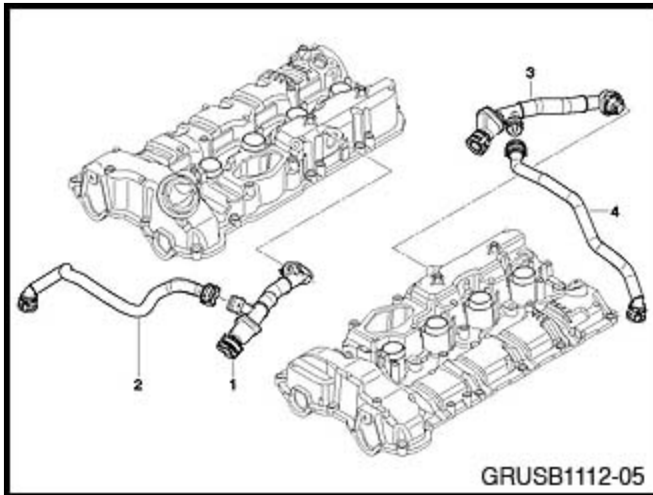
The construction material of the crankcase ventilation connection lines and vent pipes may become brittle from engine compartment temperatures.

1. Remove the engine cover and inspect the crankcase ventilation connecting lines (1) and (3).

Each of the connecting lines will have an index number printed on

the connection closest to the cylinder head cover.

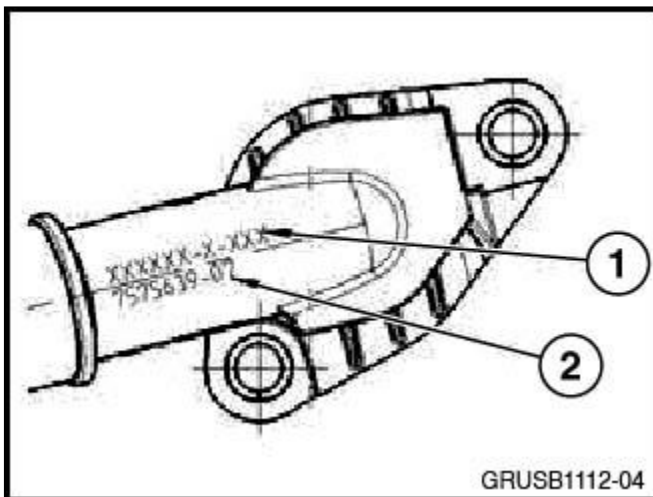
2. Production code (1)

Part Number and Index Number
(2)

Example : 7575639-07

The index number is separated from the 7-digit part number by a hyphen. In this example, it is "07".

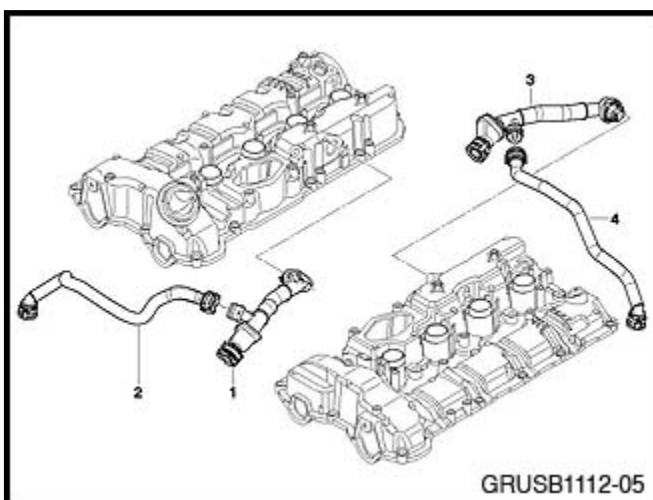
(1) Connecting line bank 1

(2) Vent pipe bank 1

(3) Connecting line bank 2

(4) Vent pipe bank 2

3. If the index number is "7" or lower, both crankcase ventilation connecting lines and vent pipes need to be replaced.

The improved replacement parts will have an index of "8" or higher.

4. Each cylinder head cover and vent pipe connection has two M6x18 screws attaching these

components. The torque specification for these screws is 10 +/- 1.5 Nm.

Important: Do not replace the cylinder head covers for this complaint.
